## **Access Compliance Report Public Rights-of-Way** (Curb Ramps)

Intersection ID: 19275 Main Street: PEBBLESTONE DR Cross Street: VILLAGE LAKE DR Location: NW ADA ID: B5A9E8CA8CAB Ramp Type: PerpDiag Initial Pass/Fail: Fail **Overall Compliance: No Severity Score:** 25

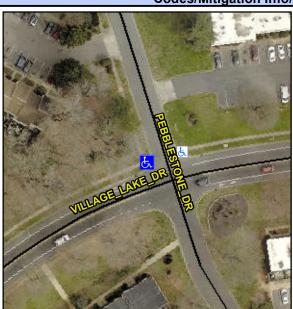
Field Measurements/Component Compliance						
Compliance Description		Data	Comp	liance	Description	Data
N/A	Ramp Length (in)	103.0	No	Ramp	Slope (%)	8.5
Yes	Ramp Width (in)	48.0	No	Ramp	XSlope (%)	5.8
N/A	Flare Type LT	N/A	N/A	Flare <sup>-</sup>	Type RT	N/A
N/A	Flare Slope LT (%)	N/A	N/A	Flare	Slope RT (%)	N/A
N/A	Flare Traversable LT?	N/A	N/A	Flare <sup>-</sup>	Traversable RT?	N/A
N/A	Landing Length (in)	N/A	N/A	DWS	Provided?	N/A
N/A	Landing Width (in)	N/A	N/A	DWS	Contrast?	N/A
N/A	Landing Slope (%)	N/A	N/A	DWS	Length (in)	N/A
N/A	Landing X Slope (%)	N/A	N/A	DWS	Full Width?	N/A
N/A	Landing Curb? (Y/N)	N/A	N/A	DWS	Offset (in)	N/A
N/A	Shared Landing?	N/A				
N/A	Gutter Ponding?	N/A	N/A	Gutter	Slope (%)	N/A
N/A	Gutter Lip Ht (in)	N/A	N/A	Gutter	X Slope (%)	N/A
N/A	Painted X Walk1?	No	N/A	Painte	ed X Walk2?	No
	X Walk 1 Direction	To S		X Wall	k 2 Direction	To E
N/A	X Walk 1 Width (in)	N/A	N/A	X Wall	k 2 Width (in)	N/A

X Walk 1 Slope (%)	1.2		X Wall	k 2 Slope (%)	2.9
	X Walk 1 X Slope (%)	5.6		X Wall	k 2 X Slope (%)	2.3
N/A	Ramp inside XWalk1?	N/A	N/A	Ramp	inside XWalk2?	N/A
	Road Slope (%)	5.3	N/A	Clear	Space?	N/A
	Road X Slope (%)	6.2	N/A	Clear	Space to XWalk (in)	N/A
N/A	Any Obstructions?	N/A	N/A	Storm	Grate/Utility Hazard?	N/A
	Obstruction Type			Storm	Grate/Utility Type	
		N/A				N/A
			Yes	Surfac	ce Condition? (G/P)	Good

**VILLAGE LAKE DR** None PEBBLESTONE DR StopSign Possible Solutions: Remove & Replace Curb Ramp With Two New Directional Ramps or Equivalent. Surveyor Notes: N/A PROW/ADA: Not Found, R304.2.2, R304.5.3
