# Access Compliance Report

## Public Rights-of-Way

### (Curb Ramps)

Intersection ID: 48608	Main Street: BULFINCH RD	Cross Street: PIEDMONT_ROW_DR	Location: SE
ADA ID: B5AC1192B78F	Ramp Type: Perp	Initial Pass/Fail: Fail	Overall Compliance: No
		Severity Score: 12.5

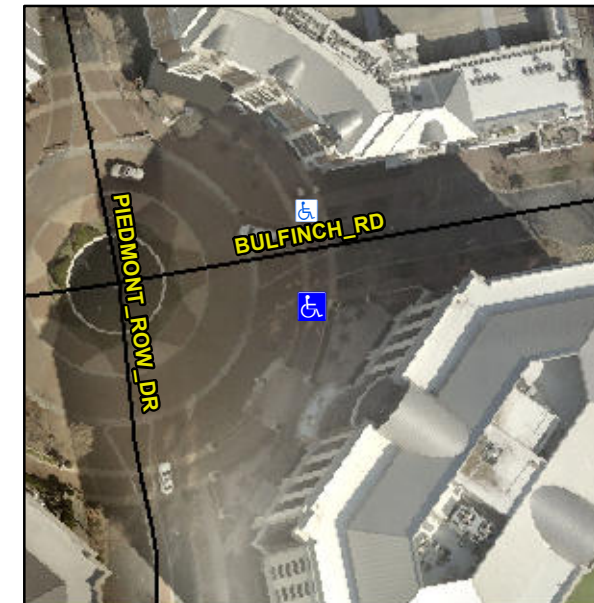
Compliance	Description	Data	Compliance	Description	Data
N/A	Ramp Length (in)	126.0	No	Ramp Slope (%)	8.6
Yes	Ramp Width (in)	106.0	Yes	Ramp XSlope (%)	1.7
N/A	Flare Type LT	N/A	N/A	Flare Type RT	N/A
N/A	Flare Slope LT (%)	N/A	N/A	Flare Slope RT (%)	N/A
N/A	Flare Traversable LT?	N/A	N/A	Flare Traversable RT?	N/A
N/A	Landing Length (in)	N/A	N/A	DWS Provided?	N/A
N/A	Landing Width (in)	N/A	N/A	DWS Contrast?	N/A
N/A	Landing Slope (%)	N/A	N/A	DWS Length (in)	N/A
N/A	Landing X Slope (%)	N/A	N/A	DWS Full Width?	N/A
N/A	Landing Curb? (Y/N)	N/A	N/A	DWS Offset (in)	N/A
N/A	Shared Landing?	N/A			
N/A	Gutter Ponding?	N/A	N/A	Gutter Slope (%)	N/A
N/A	Gutter Lip Ht (in)	N/A	N/A	Gutter X Slope (%)	N/A
N/A	Painted X Walk1?	Yes	N/A	Painted X Walk2?	N/A
	X Walk 1 Direction	To N		X Walk 2 Direction	N/A
N/A	X Walk 1 Width (in)	123.0	N/A	X Walk 2 Width (in)	N/A
	X Walk 1 Slope (%)	1.4		X Walk 2 Slope (%)	N/A
	X Walk 1 X Slope (%)	0.3		X Walk 2 X Slope (%)	N/A

N/A	Ramp inside XWalk1?	Yes	N/A	Ramp inside XWalk2?	N/A
	Road Slope (%)	N/A	N/A	Clear Space?	N/A
	Road X Slope (%)	N/A	N/A	Clear Space to XWalk (in)	N/A
N/A	Any Obstructions?	N/A	N/A	Storm Grate/Utility Hazard?	N/A
	Obstruction Type			Storm Grate/Utility Type	
		N/A			N/A
			Yes	Surface Condition? (G/P)	Good

**Remove & Replace Entire Ramp.**

**R304.2.2**

**\$ 1850.00**
