Access Compliance Report

Public Rights-of-Way

(Curb Ramps)

Intersection ID: 43691	Main Street: PORTSTEWART_LN	Cross Street: TEW_CT	Location: NW
ADA ID: B5B1777580CA	Ramp Type: BlendTrans1	Initial Pass/Fail: Fail	Overall Compliance: No
Codes/Mitigation Info/Possible Solution			Severity Score: 10
			Field Measurements/Component Compliance

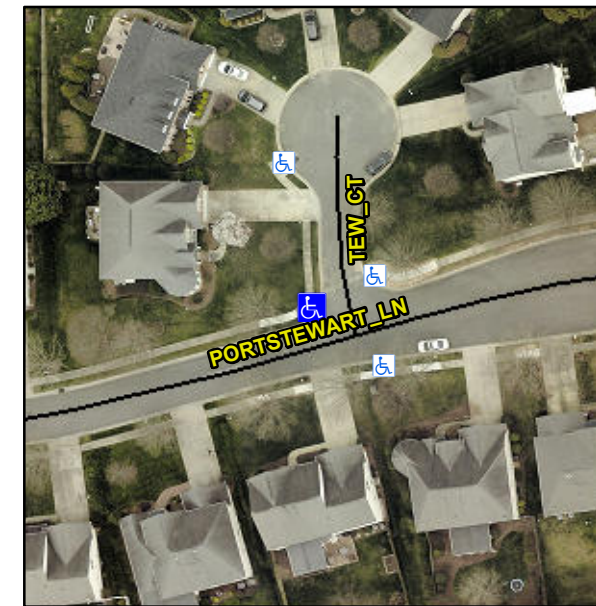
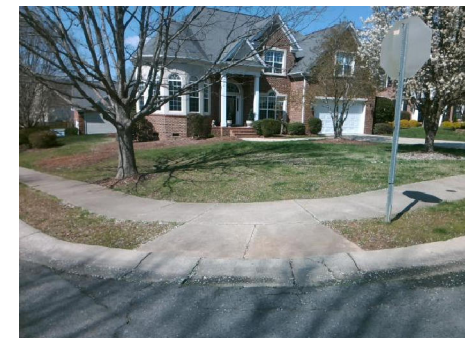
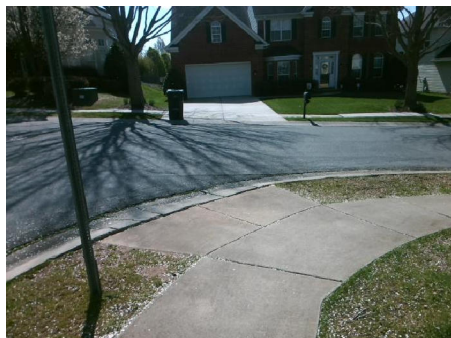
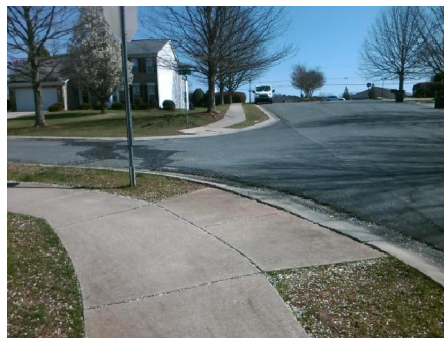
Not Found, R304.5.1, R304.5.3

Compliance	Description	Data	Compliance	Description	Data
N/A	Ramp Length (in)	47.0	Yes	BlendTrans Slope (%)	4.1
No	Ramp Width (in)	41.0	No	BlendTrans XSlope (%)	3.9
N/A	Flare Type LT	N/A	N/A	Flare Type RT	N/A
N/A	Flare Slope LT (%)	N/A	N/A	Flare Slope RT (%)	N/A
N/A	Flare Traversable LT?	N/A	N/A	Flare Traversable RT?	N/A
N/A	Landing Length (in)	N/A	N/A	DWS Provided?	N/A
N/A	Landing Width (in)	N/A	N/A	DWS Contrast?	N/A
N/A	Landing Slope (%)	N/A	N/A	DWS Length (in)	N/A
N/A	Landing X Slope (%)	N/A	N/A	DWS Full Width?	N/A
N/A	Landing Curb? (Y/N)	N/A	N/A	DWS Offset (in)	N/A
N/A	Shared Landing?	N/A			
N/A	Gutter Ponding?	N/A	N/A	Gutter Slope (%)	N/A
N/A	Gutter Lip Ht (in)	N/A	N/A	Gutter X Slope (%)	N/A
N/A	Painted X Walk1?	No	N/A	Painted X Walk2?	No
	X Walk 1 Direction	To S		X Walk 2 Direction	To E
	X Walk 1 Width (in)	N/A		X Walk 2 Width (in)	N/A
	X Walk 1 Slope (%)	2.0		X Walk 2 Slope (%)	4.9
	X Walk 1 X Slope (%)	6.7		X Walk 2 X Slope (%)	0.6

N/A	Ramp inside XWalk1?	N/A	N/A	Ramp inside XWalk2?	N/A
	Road Slope (%)	5.6		Clear Space?	N/A
	Road X Slope (%)	5.3	N/A	Clear Space to XWalk (in)	N/A
N/A	Any Obstructions?	N/A	N/A	Storm Grate/Utility Hazard?	N/A
	Obstruction Type			Storm Grate/Utility Type	
		N/A			N/A
			Yes	Surface Condition? (G/P)	Good
			No	Curb Slope (%)	15.3

Remove & Replace Curb Ramp With Two New Directional Ramps or Equivalent.
