Access Compliance Report

Public Rights-of-Way

(Curb Ramps)

Intersection ID: 42790	Main Street: CALDWELL_CROSSING_PY	Cross Street: ERWIN_RIDGE_AV	Location: S
ADA ID: B5B56EEBCFA1	Ramp Type: PerpDiag	Initial Pass/Fail: Fail	Overall Compliance: No
Severity Score: 35			
Codes/Mitigation Info/Possible Solution		Field Measurements/Component Compliance

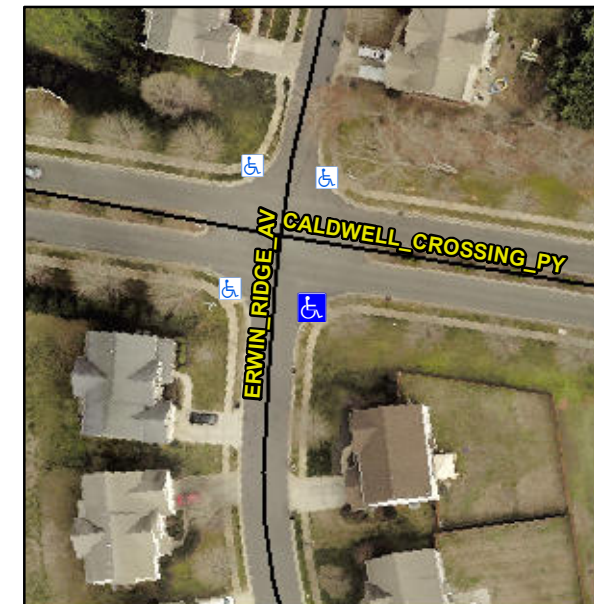
Not Found, R304.5.1, R304.2.2, R304.5.3

Compliance	Description	Data	Compliance	Description	Data
N/A	Ramp Length (in)	47.0	No	Ramp Slope (%)	14.4
No	Ramp Width (in)	36.0	No	Ramp XSlope (%)	2.5
N/A	Flare Type LT	N/A	N/A	Flare Type RT	N/A
N/A	Flare Slope LT (%)	N/A	N/A	Flare Slope RT (%)	N/A
N/A	Flare Traversable LT?	N/A	N/A	Flare Traversable RT?	N/A
N/A	Landing Length (in)	N/A	N/A	DWS Provided?	N/A
N/A	Landing Width (in)	N/A	N/A	DWS Contrast?	N/A
N/A	Landing Slope (%)	N/A	N/A	DWS Length (in)	N/A
N/A	Landing X Slope (%)	N/A	N/A	DWS Full Width?	N/A
N/A	Landing Curb? (Y/N)	N/A	N/A	DWS Offset (in)	N/A
N/A	Shared Landing?	N/A			
N/A	Gutter Ponding?	N/A	N/A	Gutter Slope (%)	N/A
N/A	Gutter Lip Ht (in)	N/A	N/A	Gutter X Slope (%)	N/A
N/A	Painted X Walk1?	No	N/A	Painted X Walk2?	No
	X Walk 1 Direction	To NE		X Walk 2 Direction	To NW
N/A	X Walk 1 Width (in)	N/A	N/A	X Walk 2 Width (in)	N/A
	X Walk 1 Slope (%)	3.9		X Walk 2 Slope (%)	3.1
	X Walk 1 X Slope (%)	0.9		X Walk 2 X Slope (%)	3.3

N/A	Ramp inside XWalk1?	N/A	N/A	Ramp inside XWalk2?	N/A
	Road Slope (%)	3.0	N/A	Clear Space?	N/A
	Road X Slope (%)	4.7	N/A	Clear Space to XWalk (in)	N/A
N/A	Any Obstructions?	N/A	N/A	Storm Grate/Utility Hazard?	N/A
	Obstruction Type			Storm Grate/Utility Type	
		N/A			N/A
			Yes	Surface Condition? (G/P)	Good

Remove & Replace Curb Ramp With Two New Directional Ramps or Equivalent.
