Access Compliance Report

Public Rights-of-Way

(Curb Ramps)

Intersection ID: 20639	Main Street: CROWN_VIEW_DR	Cross Street: TOWER_POINT_DR	Location: NE
ADA ID: B5E3E3A8508A	Ramp Type: PerpDiag	Initial Pass/Fail: Fail	Overall Compliance: No
Severity Score: 50			
Codes/Mitigation Info/Possible Solution		Field Measurements/Component Compliance

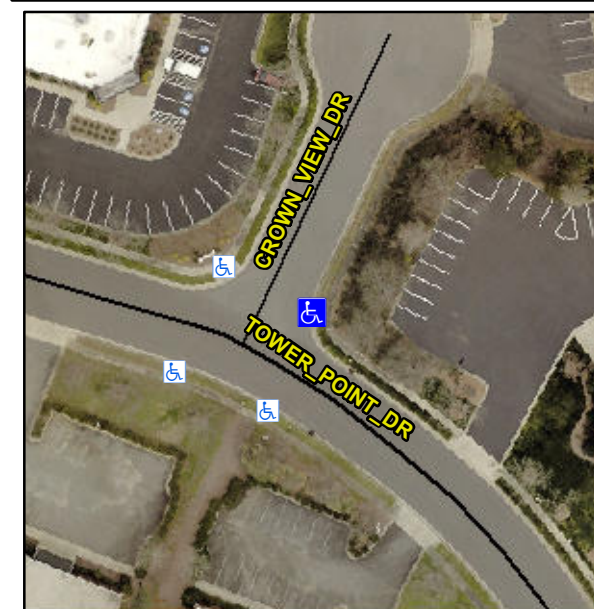
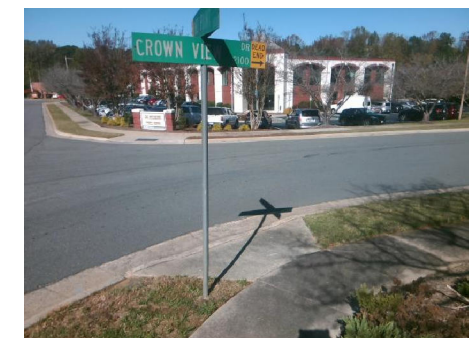
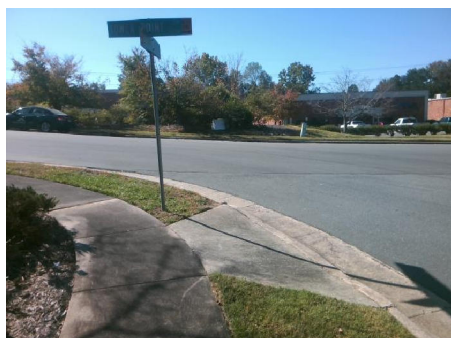
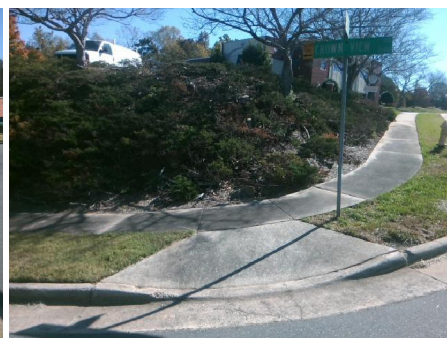
Compliance	Description	Data	Compliance	Description	Data
N/A	Ramp Length (in)	57.0	No	Ramp Slope (%)	14.9
Yes	Ramp Width (in)	48.0	No	Ramp XSlope (%)	10.8
N/A	Flare Type LT	N/A	N/A	Flare Type RT	N/A
N/A	Flare Slope LT (%)	N/A	N/A	Flare Slope RT (%)	N/A
N/A	Flare Traversable LT?	N/A	N/A	Flare Traversable RT?	N/A
N/A	Landing Length (in)	N/A	N/A	DWS Provided?	N/A
N/A	Landing Width (in)	N/A	N/A	DWS Contrast?	N/A
N/A	Landing Slope (%)	N/A	N/A	DWS Length (in)	N/A
N/A	Landing X Slope (%)	N/A	N/A	DWS Full Width?	N/A
N/A	Landing Curb? (Y/N)	N/A	N/A	DWS Offset (in)	N/A
N/A	Shared Landing?	N/A			
N/A	Gutter Ponding?	N/A	N/A	Gutter Slope (%)	N/A
N/A	Gutter Lip Ht (in)	N/A	N/A	Gutter X Slope (%)	N/A
N/A	Painted X Walk1?	No	N/A	Painted X Walk2?	No
	X Walk 1 Direction	To NW		X Walk 2 Direction	To SW
N/A	X Walk 1 Width (in)	N/A	N/A	X Walk 2 Width (in)	N/A
	X Walk 1 Slope (%)	3.2		X Walk 2 Slope (%)	10.9
	X Walk 1 X Slope (%)	6.3		X Walk 2 X Slope (%)	5.8

N/A	Ramp inside XWalk1?	N/A	N/A	Ramp inside XWalk2?	N/A
	Road Slope (%)	6.5	N/A	Clear Space?	N/A
	Road X Slope (%)	1.9	N/A	Clear Space to XWalk (in)	N/A
N/A	Any Obstructions?	N/A	N/A	Storm Grate/Utility Hazard?	N/A
	Obstruction Type			Storm Grate/Utility Type	
		N/A			N/A
			Yes	Surface Condition? (G/P)	Good

Remove & Replace Curb Ramp With Two New Directional Ramps or Equivalent.

R304.2.2, R304.5.3
