# Access Compliance Report

## Public Rights-of-Way

### (Curb Ramps)

| Intersection ID: 25967 | Main Street: PARHAM_PL | Cross Street: REDFIELD_DR | Location: NW |

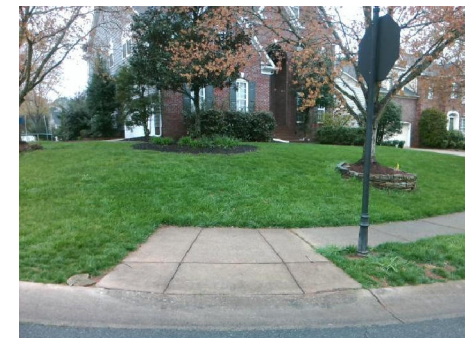
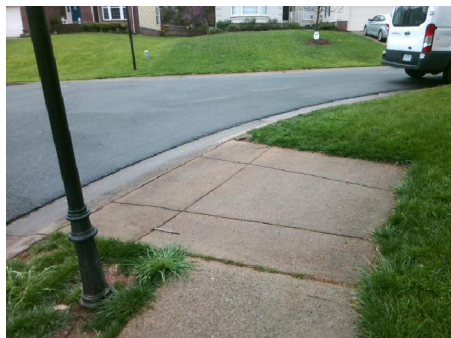
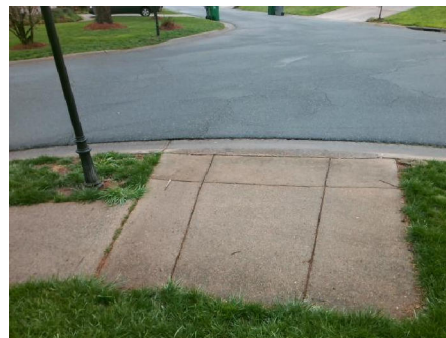
**Not Found, R304.5.1, R304.5.3**

| Compliance | Description | Data | Compliance | Description | Data |
|---|---|---|---|---|---|
| No | Ramp Width (in) | 38.0 | No | BlendTrans XSlope (%) | 3.7 |
| | | | No | Curb Slope (%) | 19.5 |

**Remove & Replace Curb Ramp With Two New Directional Ramps or Equivalent.**
