# Access Compliance Report

## Public Rights-of-Way

### (Curb Ramps)

Intersection ID: 20132	Main Street: SARDIS_RD	Cross Street: WINGRAVE_DR	Location: NW
ADA ID: B5EB9CB8586E	Ramp Type: PerpDiag	Initial Pass/Fail: Fail	Overall Compliance: No
Severity Score: 21.25			
Codes/Mitigation Info/Possible Solution		Field Measurements/Component Compliance

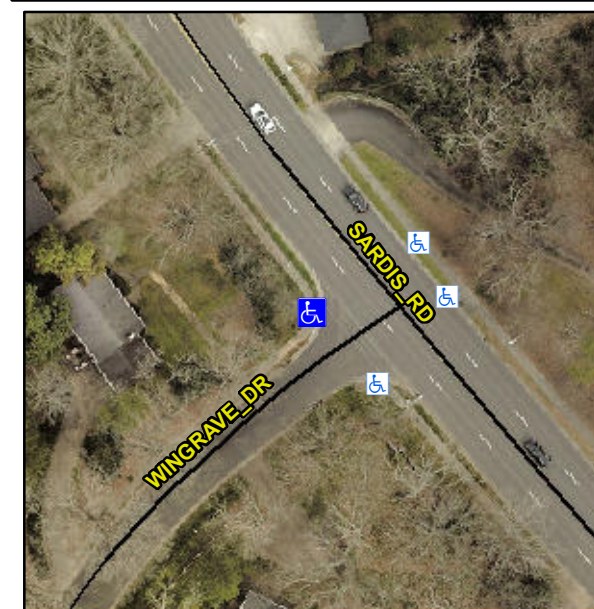
**Not Found, R304.5.1, R304.2.2**

Compliance	Description	Data	Compliance	Description	Data
N/A	Ramp Length (in)	71.0	No	Ramp Slope (%)	9.1
No	Ramp Width (in)	38.0	Yes	Ramp XSlope (%)	1.8
N/A	Flare Type LT	N/A	N/A	Flare Type RT	N/A
N/A	Flare Slope LT (%)	N/A	N/A	Flare Slope RT (%)	N/A
N/A	Flare Traversable LT?	N/A	N/A	Flare Traversable RT?	N/A
N/A	Landing Length (in)	N/A	N/A	DWS Provided?	N/A
N/A	Landing Width (in)	N/A	N/A	DWS Contrast?	N/A
N/A	Landing Slope (%)	N/A	N/A	DWS Length (in)	N/A
N/A	Landing X Slope (%)	N/A	N/A	DWS Full Width?	N/A
N/A	Landing Curb? (Y/N)	N/A	N/A	DWS Offset (in)	N/A
N/A	Shared Landing?	N/A			
N/A	Gutter Ponding?	N/A	N/A	Gutter Slope (%)	N/A
N/A	Gutter Lip Ht (in)	N/A	N/A	Gutter X Slope (%)	N/A
N/A	Painted X Walk1?	No	N/A	Painted X Walk2?	No
	X Walk 1 Direction	To SE		X Walk 2 Direction	To NE
N/A	X Walk 1 Width (in)	N/A	N/A	X Walk 2 Width (in)	N/A
	X Walk 1 Slope (%)	2.9		X Walk 2 Slope (%)	3.4
	X Walk 1 X Slope (%)	2.7		X Walk 2 X Slope (%)	2.8

N/A	Ramp inside XWalk1?	N/A	N/A	Ramp inside XWalk2?	N/A
	Road Slope (%)	0.6	N/A	Clear Space?	N/A
	Road X Slope (%)	3.7	N/A	Clear Space to XWalk (in)	N/A
N/A	Any Obstructions?	N/A	N/A	Storm Grate/Utility Hazard?	N/A
	Obstruction Type			Storm Grate/Utility Type	
		N/A			N/A
		Yes		Surface Condition? (G/P)	Good

**Remove & Replace Curb Ramp With Two New Directional Ramps or Equivalent.**

Total Cost: \$ 3200.00
