Access Compliance Report

Public Rights-of-Way

(Curb Ramps)

Intersection ID: 29693	Main Street: OAKTON_RIDGE_CT	Cross Street: WEDDINGTON_RIDGE_LN	Location: W
ADA ID: B5EF986C3CCD	Ramp Type: Perp	Initial Pass/Fail: Fail	Overall Compliance: No
Codes/Mitigation Info/Possible Solution		Field Measurements/Component Compliance

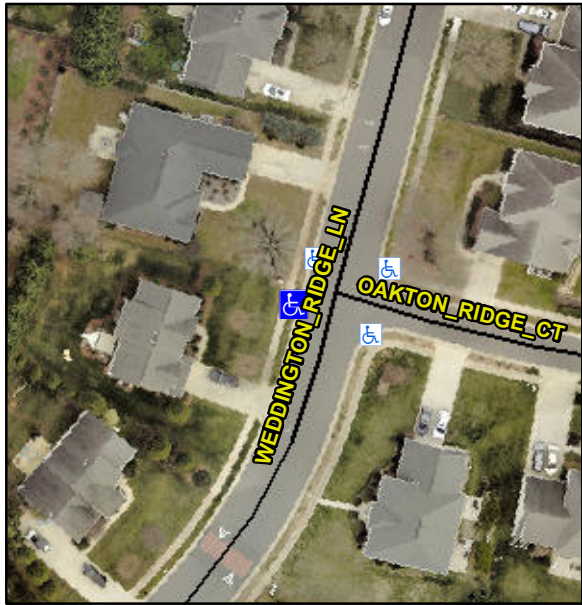
Compliance	Description	Data	Compliance	Description	Data
N/A	Ramp Length (in)	48.5	No	Ramp Slope (%)	8.8
Yes	Ramp Width (in)	48.0	Yes	Ramp XSlope (%)	2.3
N/A	Flare Type LT	N/A	N/A	Flare Type RT	N/A
N/A	Flare Slope LT (%)	N/A	N/A	Flare Slope RT (%)	N/A
N/A	Flare Traversable LT?	N/A	N/A	Flare Traversable RT?	N/A
N/A	Landing Length (in)	N/A	N/A	DWS Provided?	N/A
N/A	Landing Width (in)	N/A	N/A	DWS Contrast?	N/A
N/A	Landing Slope (%)	N/A	N/A	DWS Length (in)	N/A
N/A	Landing X Slope (%)	N/A	N/A	DWS Full Width?	N/A
N/A	Landing Curb? (Y/N)	N/A	N/A	DWS Offset (in)	N/A
N/A	Shared Landing?	N/A			
N/A	Gutter Ponding?	N/A	N/A	Gutter Slope (%)	N/A
N/A	Gutter Lip Ht (in)	N/A	N/A	Gutter X Slope (%)	N/A
N/A	Painted X Walk1?	No	N/A	Painted X Walk2?	N/A
	X Walk 1 Direction	To SE		X Walk 2 Direction	N/A
N/A	X Walk 1 Width (in)	N/A	N/A	X Walk 2 Width (in)	N/A
	X Walk 1 Slope (%)	4.3		X Walk 2 Slope (%)	N/A
	X Walk 1 X Slope (%)	3.5		X Walk 2 X Slope (%)	N/A

N/A	Ramp inside XWalk1?	N/A	N/A	Ramp inside XWalk2?	N/A
	Road Slope (%)	N/A	N/A	Clear Space?	N/A
	Road X Slope (%)	N/A	N/A	Clear Space to XWalk (in)	N/A
N/A	Any Obstructions?	N/A	N/A	Storm Grate/Utility Hazard?	N/A
	Obstruction Type			Storm Grate/Utility Type	
		N/A			N/A
			Yes	Surface Condition? (G/P)	Good

Possible Solutions:			
	Remove & Replace Entire Ramp.			
	Surveyor Notes:			
	N/A			
	PROW/ADA:			
	Not Found, R304.2.2			
	Total Cost:		\$	1850.00
