Access Compliance Report

Public Rights-of-Way

(Curb Ramps)

Intersection ID: 20224	Main Street: DINGESS_RD	Cross Street: KEARNEY_CT	Location: NW
ADA ID: B5F5A47E25EF	Ramp Type: PerpDiag	Initial Pass/Fail: Fail	Overall Compliance: No
Severity Score: 48.75			
Codes/Mitigation Info/Possible Solution		Field Measurements/Component Compliance

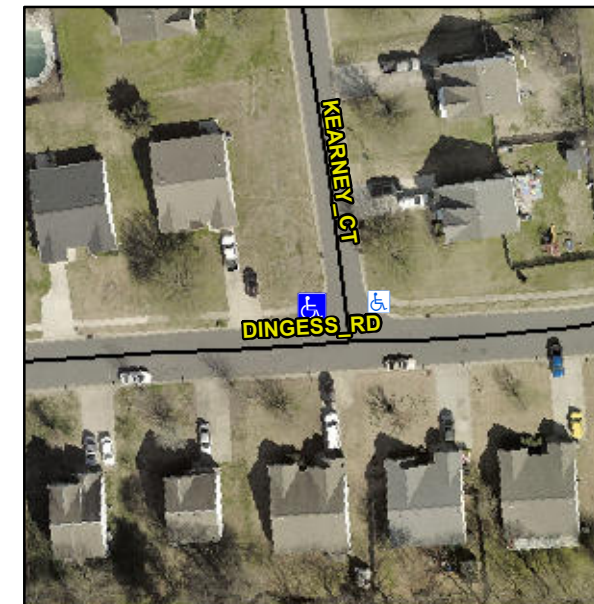
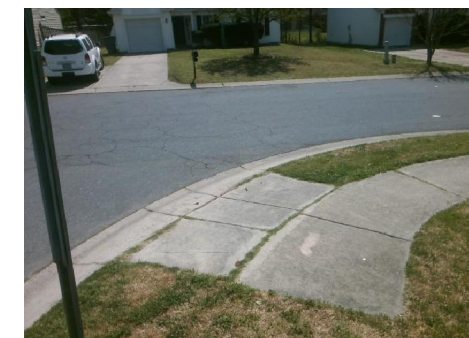
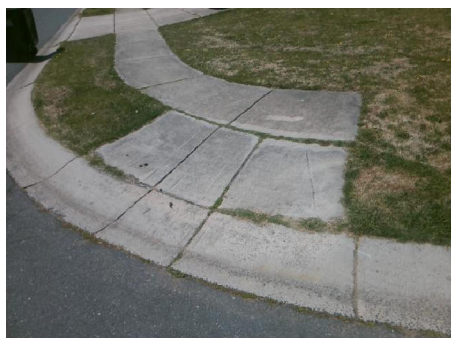
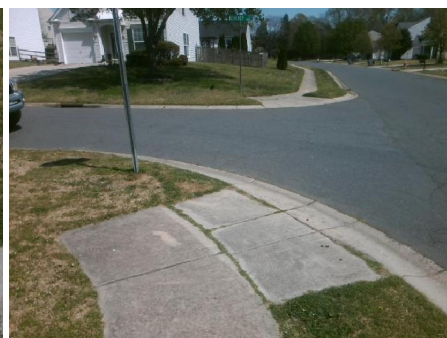
Not Found, R304.5.1, R304.2.2, R304.5.3

Compliance	Description	Data	Compliance	Description	Data
N/A	Ramp Length (in)	47.0	No	Ramp Slope (%)	8.5
No	Ramp Width (in)	25.0	No	Ramp XSlope (%)	2.1
N/A	Flare Type LT	N/A	N/A	Flare Type RT	N/A
N/A	Flare Slope LT (%)	N/A	N/A	Flare Slope RT (%)	N/A
N/A	Flare Traversable LT?	N/A	N/A	Flare Traversable RT?	N/A
N/A	Landing Length (in)	N/A	N/A	DWS Provided?	N/A
N/A	Landing Width (in)	N/A	N/A	DWS Contrast?	N/A
N/A	Landing Slope (%)	N/A	N/A	DWS Length (in)	N/A
N/A	Landing X Slope (%)	N/A	N/A	DWS Full Width?	N/A
N/A	Landing Curb? (Y/N)	N/A	N/A	DWS Offset (in)	N/A
N/A	Shared Landing?	N/A			
N/A	Gutter Ponding?	N/A	N/A	Gutter Slope (%)	N/A
N/A	Gutter Lip Ht (in)	N/A	N/A	Gutter X Slope (%)	N/A
N/A	Painted X Walk1?	No	N/A	Painted X Walk2?	No
	X Walk 1 Direction	To S		X Walk 2 Direction	To E
N/A	X Walk 1 Width (in)	N/A	N/A	X Walk 2 Width (in)	N/A
	X Walk 1 Slope (%)	3.4		X Walk 2 Slope (%)	5.2
	X Walk 1 X Slope (%)	3.7		X Walk 2 X Slope (%)	2.2

N/A	Ramp inside XWalk1?	N/A	N/A	Ramp inside XWalk2?	N/A
	Road Slope (%)	2.7	N/A	Clear Space?	N/A
	Road X Slope (%)	4.2	N/A	Clear Space to XWalk (in)	N/A
N/A	Any Obstructions?	N/A	N/A	Storm Grate/Utility Hazard?	N/A
	Obstruction Type			Storm Grate/Utility Type	
		N/A			N/A
		Yes		Surface Condition? (G/P)	Good

Remove & Replace Curb Ramp With Two New Directional Ramps or Equivalent.
