Access Compliance Report

Public Rights-of-Way

(Curb Ramps)

| Intersection ID: 10028782 | Main Street: HUNTINGTOWNE_FARMS_LN | Cross Street: N/A | Location: SW |

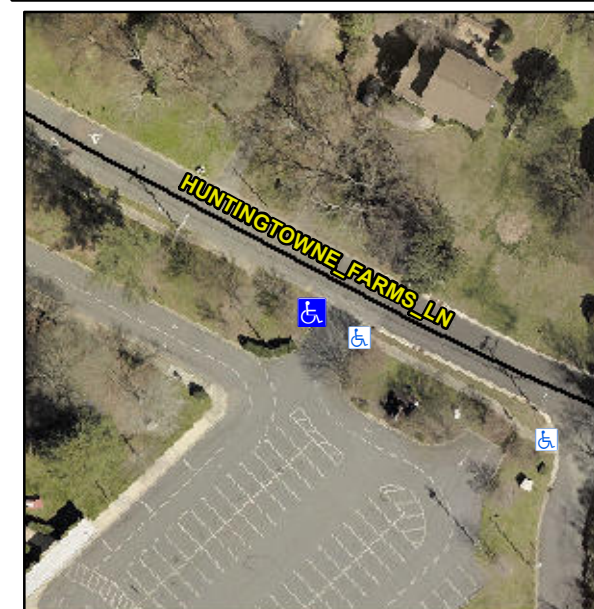
| ADA ID: B5F5F244CC17 | Ramp Type: Perp | Initial Pass/Fail: Fail | Overall Compliance: No |
| Severity Score: 26.25 | | | |

R304.2.2, R304.5.3

| Compliance | Description | Data | Compliance | Description | Data |
|---|---|---|---|---|---|
| N/A | Ramp Length (in) | 73.0 | No | Ramp Slope (%) | 12.3 |
| Yes | Ramp Width (in) | 48.0 | No | Ramp XSlope (%) | 4.1 |

Possible Solutions:

Remove & Replace Entire Ramp.

Total Cost:

\$ 1850.00
