# Access Compliance Report

## Public Rights-of-Way

### (Curb Ramps)

Intersection ID: N/A	Main Street: BALLANTYNE CORPORATE PL	Cross Street: N/A	Location: NE
ADA ID: B60AB098FA08	Ramp Type: Directional	Initial Pass/Fail: Fail	Overall Compliance: No
Codes/Mitigation Info/Possible Solution		Field Measurements/Component Compliance	
Severity Score: 21.25

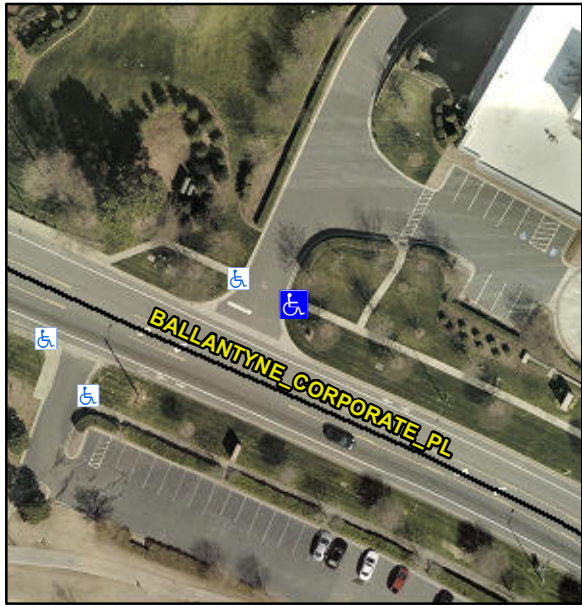
Compliance	Description	Data	Compliance	Description	Data
N/A	Ramp Length (in)	76.0	N/A	Grade Break?	N/A
No	Ramp Width (in)	47.0	N/A	Grade Break Slope (%)	0.0
No	Ramp Slope (%)	8.6	N/A	Grade Break XSlope (%)	0.0
Yes	Ramp XSlope (%)	1.9			
N/A	Flare Type LT	N/A	N/A	Flare Type RT	N/A
N/A	Flare Slope LT (%)	N/A	N/A	Flare Slope RT (%)	0.0
N/A	Flare Traversable LT?	N/A	N/A	Flare Traversable RT?	N/A
N/A	Landing Length (in)	0.0	N/A	DWS Provided?	N/A
N/A	Landing Width (in)	0.0	N/A	DWS Contrast?	N/A
N/A	Landing Slope (%)	0.0	N/A	DWS Length (in)	N/A
N/A	Landing X Slope (%)	0.0	N/A	DWS Full Width?	N/A
N/A	Landing Curb? (Y/N)	N/A	N/A	DWS Offset LT (in)	N/A
N/A	Shared Landing?	N/A	N/A	DWS Offset RT (in)	N/A
N/A	Gutter Ponding?	0.0	N/A	Gutter Slope (%)	N/A
N/A	Gutter Lip Ht (in)	0.0	N/A	Gutter X Slope (%)	N/A
N/A	Painted X Walk1?	No		Road Slope (%)	2.3
	X Walk 1 Direction	To NW		Road X Slope (%)	2.4
	X Walk 1 Width (in)	N/A		Clear Space?	N/A

X Walk 1 Slope (%)	2.3	N/A	Clear Space to XWalk (in)	N/A
	X Walk 1 X Slope (%)	2.4	N/A	Storm Grate/Utility Hazard?	N/A
N/A	Ramp inside XWalk1?	N/A		Storm Grate/Utility Type	
N/A	Any Obstructions?	N/A			N/A
	Obstruction Type		Yes	Surface Condition? (G/P)	Good
		N/A	N/A	Curb Slope (%)	6.0

Possible Solutions:

Remove & Replace Entire Ramp.

R304.5.1, R304.2.2

Total Cost:\$1600.00
