# Access Compliance Report

## Public Rights-of-Way

### (Curb Ramps)

Intersection ID: 49399	Main Street: CHILFORD_CT	Cross Street: HEREFORD_ST	Location: SW
ADA ID: B6131439218F	Ramp Type: PerpDiag	Initial Pass/Fail: Fail	Overall Compliance: No
Codes/Mitigation Info/Possible Solution		Field Measurements/Component Compliance	
Severity Score: 10

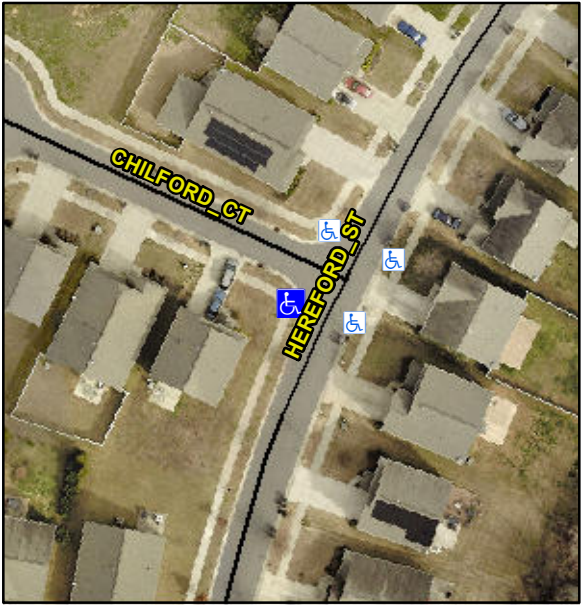
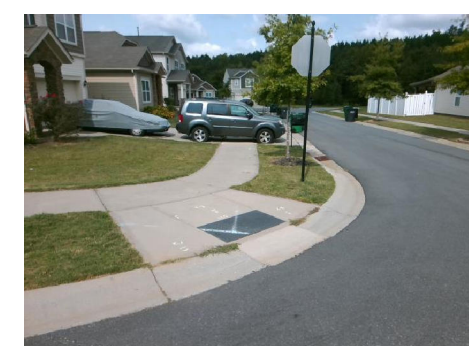
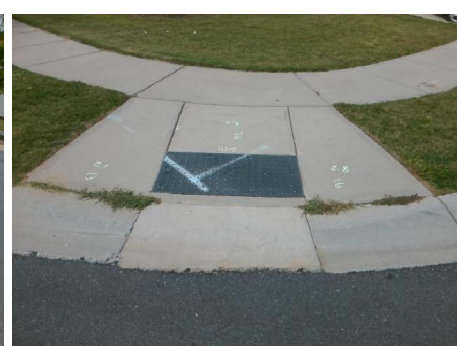
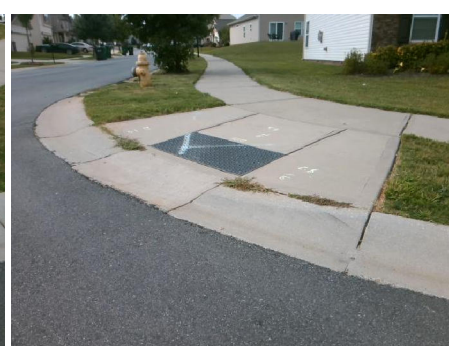
Possible Solutions:		Compliance		Description		Data	Compliance	Description	Data
	Remove & Replace Curb Ramp With Two New Directional Ramps or Equivalent.		N/A		Ramp Length (in)		74.0	Yes	Ramp Slope (%)	7.6
<p>Surveyor Notes:</p> <p>N/A</p>			No		Ramp Width (in)		47.5	No	Ramp XSlope (%)	4.7
			N/A		Flare Type LT		N/A	N/A	Flare Type RT	N/A
<p>PROW/ADA:</p> <p>Not Found, R304.5.1, R304.5.3</p>			N/A		Flare Slope LT (%)		N/A	N/A	Flare Slope RT (%)	N/A
			N/A		Flare Traversable LT?		N/A	N/A	Flare Traversable RT?	N/A
<p>Total Cost:</p> <p>\$ 3200.00</p>			N/A		Landing Length (in)		N/A	N/A	DWS Provided?	N/A
			N/A		Landing Width (in)		N/A	N/A	DWS Contrast?	N/A
			N/A		Landing Slope (%)		N/A	N/A	DWS Length (in)	N/A
			N/A		Landing X Slope (%)		N/A	N/A	DWS Full Width?	N/A
			N/A		Landing Curb? (Y/N)		N/A	N/A	DWS Offset (in)	N/A
			N/A		Shared Landing?		N/A			
			N/A		Gutter Ponding?		N/A	N/A	Gutter Slope (%)	N/A

N/A		Gutter Lip Ht (in)		N/A	N/A	Gutter X Slope (%)	N/A
			N/A		Painted X Walk1?		No	N/A	Painted X Walk2?	No
					X Walk 1 Direction		To SE		X Walk 2 Direction	To NE
			N/A		X Walk 1 Width (in)		N/A	N/A	X Walk 2 Width (in)	N/A
					X Walk 1 Slope (%)		1.3		X Walk 2 Slope (%)	1.6
					X Walk 1 X Slope (%)		2.1		X Walk 2 X Slope (%)	2.8
			N/A		Ramp inside XWalk1?		N/A	N/A	Ramp inside XWalk2?	N/A
					Road Slope (%)		3.9	N/A	Clear Space?	N/A
					Road X Slope (%)		2.2	N/A	Clear Space to XWalk (in)	N/A
			N/A		Any Obstructions?		N/A	N/A	Storm Grate/Utility Hazard?	N/A
					Obstruction Type				Storm Grate/Utility Type	
								N/A		N/A
								Yes	Surface Condition? (G/P)	Good
