Access Compliance Report

Public Rights-of-Way

(Curb Ramps)

Intersection ID: N/A	Main Street: LADY LIBERTY LN	Cross Street: TANYARD LN	Location: E
ADA ID: B62262A1D198	Ramp Type: PerpDiag	Initial Pass/Fail: Fail	Overall Compliance: No
			Severity Score: 18.75

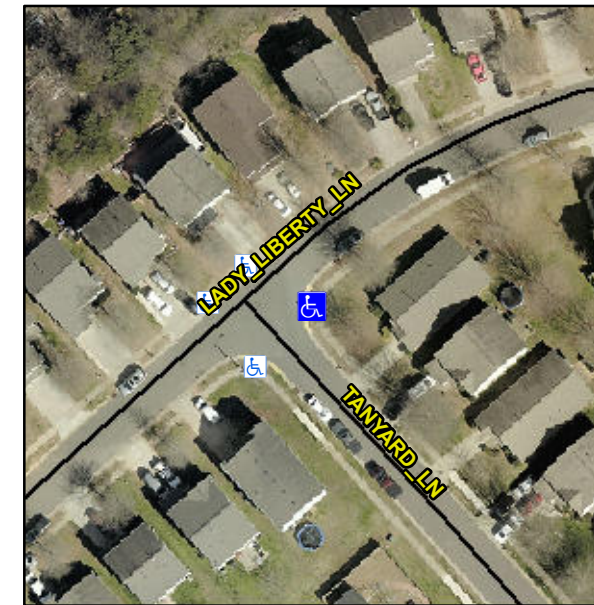
Not Found, R304.5.1, R304.5.3

Compliance	Description	Data	Compliance	Description	Data
N/A	Ramp Length (in)	51.0	Yes	Ramp Slope (%)	7.8
No	Ramp Width (in)	34.5	No	Ramp XSlope (%)	4.3
N/A	Flare Type LT	N/A	N/A	Flare Type RT	N/A
N/A	Flare Slope LT (%)	N/A	N/A	Flare Slope RT (%)	N/A
N/A	Flare Traversable LT?	No	N/A	Flare Traversable RT?	No
N/A	Landing Length (in)	N/A	N/A	DWS Provided?	N/A
N/A	Landing Width (in)	N/A	N/A	DWS Contrast?	N/A
N/A	Landing Slope (%)	N/A	N/A	DWS Length (in)	N/A
N/A	Landing X Slope (%)	N/A	N/A	DWS Full Width?	N/A
N/A	Landing Curb? (Y/N)	N/A	N/A	DWS Offset (in)	N/A
N/A	Shared Landing?	N/A			
N/A	Gutter Ponding?	N/A	N/A	Gutter Slope (%)	N/A
N/A	Gutter Lip Ht (in)	N/A	N/A	Gutter X Slope (%)	N/A
N/A	Painted X Walk1?	No	N/A	Painted X Walk2?	No
	X Walk 1 Direction	To NW		X Walk 2 Direction	To SW
N/A	X Walk 1 Width (in)	N/A	N/A	X Walk 2 Width (in)	N/A
	X Walk 1 Slope (%)	5.6		X Walk 2 Slope (%)	1.3
	X Walk 1 X Slope (%)	0.9		X Walk 2 X Slope (%)	4.2

N/A	Ramp inside XWalk1?	No	N/A	Ramp inside XWalk2?	No
	Road Slope (%)	2.8	N/A	Clear Space?	N/A
	Road X Slope (%)	5.3	N/A	Clear Space to XWalk (in)	N/A
N/A	Any Obstructions?	N/A	N/A	Storm Grate/Utility Hazard?	N/A
	Obstruction Type			Storm Grate/Utility Type	
		N/A			N/A
			Yes	Surface Condition? (G/P)	Good

Remove & Replace Curb Ramp With Two New Directional Ramps or Equivalent.
