Access Compliance Report

Public Rights-of-Way

(Curb Ramps)

Intersection ID: N/A	Main Street: HORACE_ST	Cross Street: N/A	Location: NW
ADA ID: B63144EA7E51	Ramp Type: Directional1	Initial Pass/Fail: Fail	Overall Compliance: No
		Severity Score: 1.25

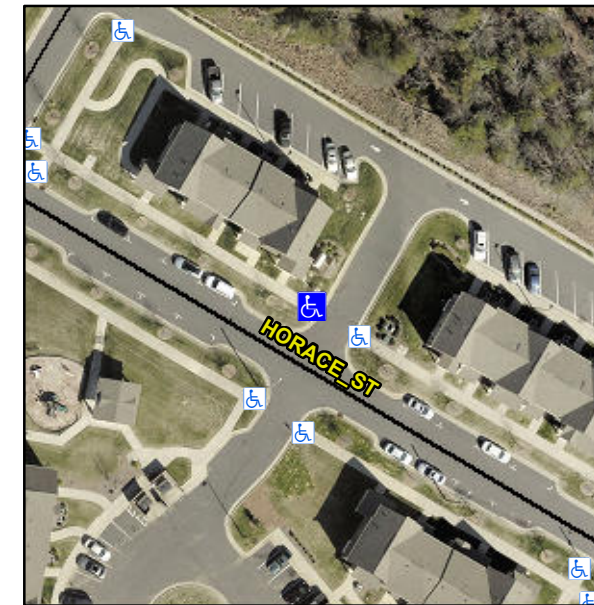
R304.5.3

Compliance	Description	Data	Compliance	Description	Data
N/A	Ramp Length (in)	24.5	N/A	Grade Break?	N/A
Yes	Ramp Width (in)	69.0	N/A	Grade Break Slope (%)	0.0
Yes	Ramp Slope (%)	3.0	N/A	Grade Break XSlope (%)	0.0
No	Ramp XSlope (%)	3.3			
N/A	Flare Type LT	N/A	N/A	Flare Type RT	N/A
N/A	Flare Slope LT (%)	N/A	N/A	Flare Slope RT (%)	0.0
N/A	Flare Traversable LT?	N/A	N/A	Flare Traversable RT?	N/A
N/A	Landing Length (in)	0.0	N/A	DWS Provided?	N/A
N/A	Landing Width (in)	0.0	N/A	DWS Contrast?	N/A
N/A	Landing Slope (%)	0.0	N/A	DWS Length (in)	N/A
N/A	Landing X Slope (%)	0.0	N/A	DWS Full Width?	N/A
N/A	Landing Curb? (Y/N)	N/A	N/A	DWS Offset LT (in)	N/A
N/A	Shared Landing?	N/A	N/A	DWS Offset RT (in)	N/A
N/A	Gutter Ponding?	0.0	N/A	Gutter Slope (%)	N/A
N/A	Gutter Lip Ht (in)	0.0	N/A	Gutter X Slope (%)	N/A
N/A	Painted X Walk1?	No		Road Slope (%)	6.5
	X Walk 1 Direction	To E		Road X Slope (%)	2.8
	X Walk 1 Width (in)	N/A		Clear Space?	N/A

X Walk 1 Slope (%)	6.5	N/A	Clear Space to XWalk (in)	N/A
	X Walk 1 X Slope (%)	2.8	N/A	Storm Grate/Utility Hazard?	N/A
N/A	Ramp inside XWalk1?	N/A		Storm Grate/Utility Type	
N/A	Any Obstructions?	N/A			N/A
	Obstruction Type		Yes	Surface Condition? (G/P)	Good
			N/A	Curb Slope (%)	6.4

Possible Solutions:

Remove & Replace Entire Ramp.

Total Cost: \$ 1600.00
