Access Compliance Report

Public Rights-of-Way

(Curb Ramps)

Intersection ID: 54779	Main Street: INDEPENDENCE/I-277_RA	Cross Street: N_SHARON_AMITY_RD	Location: NW
ADA ID: B6324E35CDD2	Ramp Type: Perp	Initial Pass/Fail: Fail	Overall Compliance: No
Severity Score: 13.75			
Codes/Mitigation Info/Possible Solution		Field Measurements/Component Compliance

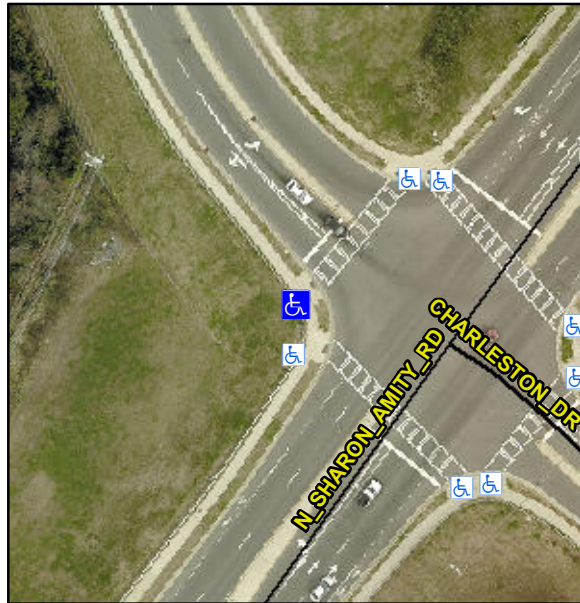
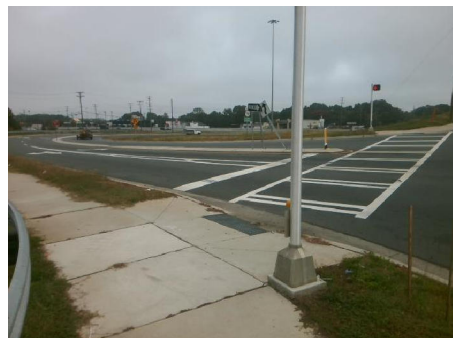
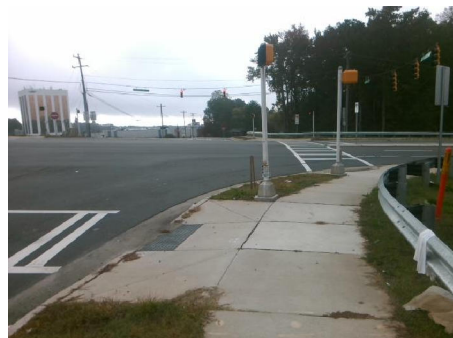
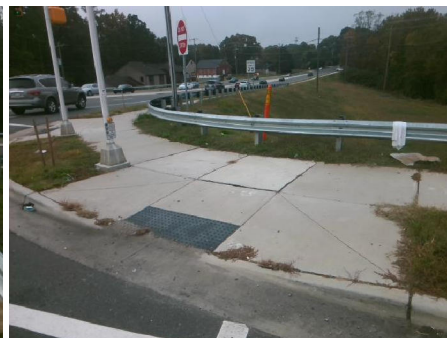
Compliance	Description	Data	Compliance	Description	Data
N/A	Ramp Length (in)	65.0	No	Ramp Slope (%)	9.4
Yes	Ramp Width (in)	59.0	No	Ramp XSlope (%)	3.2
N/A	Flare Type LT	N/A	N/A	Flare Type RT	N/A
N/A	Flare Slope LT (%)	N/A	N/A	Flare Slope RT (%)	N/A
N/A	Flare Traversable LT?	N/A	N/A	Flare Traversable RT?	N/A
N/A	Landing Length (in)	N/A	N/A	DWS Provided?	N/A
N/A	Landing Width (in)	N/A	N/A	DWS Contrast?	N/A
N/A	Landing Slope (%)	N/A	N/A	DWS Length (in)	N/A
N/A	Landing X Slope (%)	N/A	N/A	DWS Full Width?	N/A
N/A	Landing Curb? (Y/N)	N/A	N/A	DWS Offset (in)	N/A
N/A	Shared Landing?	N/A			
N/A	Gutter Ponding?	N/A	N/A	Gutter Slope (%)	N/A
N/A	Gutter Lip Ht (in)	N/A	N/A	Gutter X Slope (%)	N/A
N/A	Painted X Walk1?	Yes	N/A	Painted X Walk2?	N/A
	X Walk 1 Direction	To NE		X Walk 2 Direction	N/A
N/A	X Walk 1 Width (in)	111.0	N/A	X Walk 2 Width (in)	N/A
	X Walk 1 Slope (%)	6.8		X Walk 2 Slope (%)	N/A
	X Walk 1 X Slope (%)	2.8		X Walk 2 X Slope (%)	N/A

N/A	Ramp inside XWalk1?	Yes	N/A	Ramp inside XWalk2?	N/A
	Road Slope (%)	N/A	N/A	Clear Space?	N/A
	Road X Slope (%)	N/A	N/A	Clear Space to XWalk (in)	N/A
N/A	Any Obstructions?	N/A	N/A	Storm Grate/Utility Hazard?	N/A
	Obstruction Type			Storm Grate/Utility Type	
		N/A			N/A
		Yes		Surface Condition? (G/P)	Good

Possible Solutions:

Remove & Replace Entire Ramp.

R304.2.2, R304.5.3
