# Access Compliance Report

## Public Rights-of-Way

### (Curb Ramps)

Intersection ID: 3642	Main Street: PERIMETER_WOODS_DR	Cross Street: PERIMETER_PY	Location: SW
ADA ID: B63AB0A2AA76	Ramp Type: Perp	Initial Pass/Fail: Fail	Overall Compliance: No
Severity Score: 21.25			
Codes/Mitigation Info/Possible Solution		Field Measurements/Component Compliance

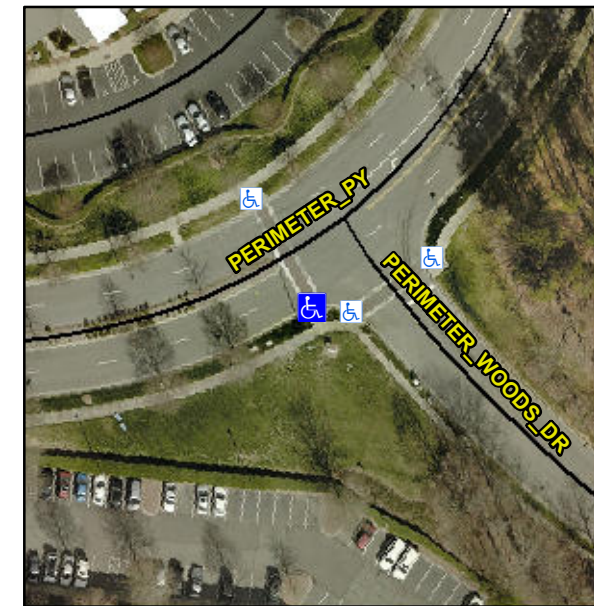
**Not Found, R304.5.1, R304.5.3**

Compliance	Description	Data	Compliance	Description	Data
N/A	Ramp Length (in)	88.0	Yes	Ramp Slope (%)	5.8
No	Ramp Width (in)	47.5	No	Ramp XSlope (%)	5.1
N/A	Flare Type LT	N/A	N/A	Flare Type RT	N/A
N/A	Flare Slope LT (%)	N/A	N/A	Flare Slope RT (%)	N/A
N/A	Flare Traversable LT?	N/A	N/A	Flare Traversable RT?	N/A
N/A	Landing Length (in)	N/A	N/A	DWS Provided?	N/A
N/A	Landing Width (in)	N/A	N/A	DWS Contrast?	N/A
N/A	Landing Slope (%)	N/A	N/A	DWS Length (in)	N/A
N/A	Landing X Slope (%)	N/A	N/A	DWS Full Width?	N/A
N/A	Landing Curb? (Y/N)	N/A	N/A	DWS Offset (in)	N/A
N/A	Shared Landing?	N/A			
N/A	Gutter Ponding?	N/A	N/A	Gutter Slope (%)	N/A
N/A	Gutter Lip Ht (in)	N/A	N/A	Gutter X Slope (%)	N/A
N/A	Painted X Walk1?	Yes	N/A	Painted X Walk2?	N/A
	X Walk 1 Direction	To NW		X Walk 2 Direction	N/A
N/A	X Walk 1 Width (in)	71.0	N/A	X Walk 2 Width (in)	N/A
	X Walk 1 Slope (%)	0.4		X Walk 2 Slope (%)	N/A
	X Walk 1 X Slope (%)	1.9		X Walk 2 X Slope (%)	N/A

N/A	Ramp inside XWalk1?	Yes	N/A	Ramp inside XWalk2?	N/A
	Road Slope (%)	N/A	N/A	Clear Space?	N/A
	Road X Slope (%)	N/A	N/A	Clear Space to XWalk (in)	N/A
N/A	Any Obstructions?	N/A	N/A	Storm Grate/Utility Hazard?	N/A
	Obstruction Type			Storm Grate/Utility Type	
		N/A			N/A
		Yes		Surface Condition? (G/P)	Good

**Remove & Replace Entire Ramp.**

Total Cost: \$ 1850.00
