Access Compliance Report

Public Rights-of-Way

(Curb Ramps)

| Intersection ID: 29359 | Main Street: MOSSBURG_CT | Cross Street: REALTREE_LN | Location: E |

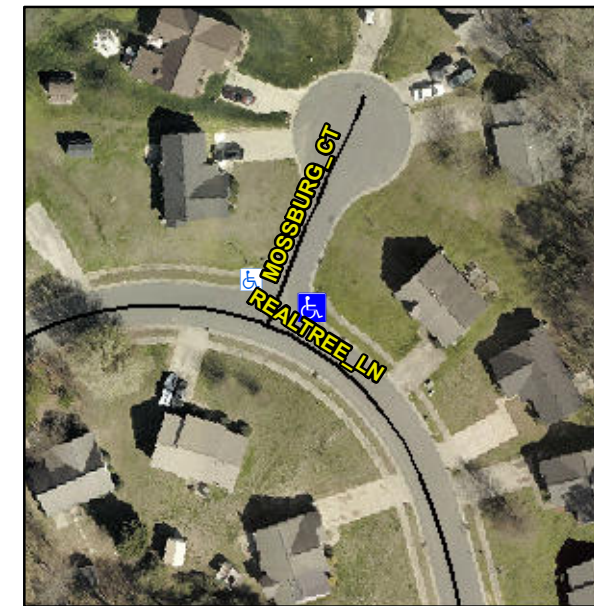
Not Found, R304.5.1, R304.5.3

| Compliance | Description | Data | Compliance | Description | Data |
|---|---|---|---|---|---|
| No | Ramp Width (in) | 46.0 | No | Ramp XSlope (%) | 3.3 |

Remove & Replace Entire Ramp.

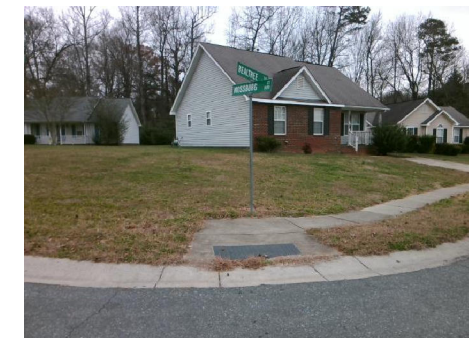
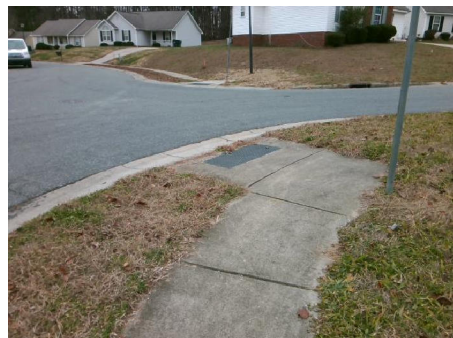
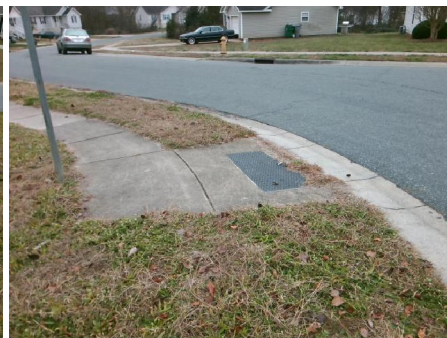
| Compliance | Description | Data | Compliance | Description | Data |
|---|---|---|---|---|---|
| N/A | Ramp Length (in) | 48.0 | Yes | Ramp Slope (%) | 5.4 |
