Access Compliance Report Public Rights-of-Way (Curb Ramps)

Intersection ID: 11369 Main Street: CATAWBA AV **Cross Street: LOLA AV** Location: SE ADA ID: B652D716D0F5 Ramp Type: BlendTrans2 Initial Pass/Fail: Fail **Overall Compliance: No**

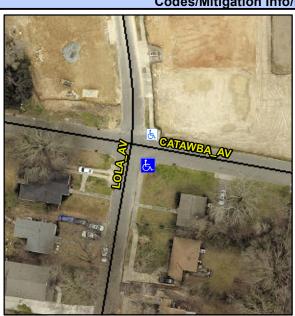
Obstruction Type			Storm Grate/Utility Type	
	N/A			N/A
		Yes	Surface Condition? (G/P)	Good
		No	Curb Slope (%)	9.0

Possible Solution			Field Me
Possible Solutions:	Comp	liance	Description
Remove & Replace Curb Ramp With	N/A	Ram	p Length (in)
Two New Directional Ramps or	No	Ram	p Width (in)
Equivalent.	N/A	Flare	e Type LT
	N/A	Flare	e Slope LT (%)
	N/A	Flare	e Traversable L
	N/A	Land	ling Length (in)
Surveyor Notes:	N/A	Land	ling Width (in)
NO LT SW	N/A	Land	ling Slope (%)
	N/A	Land	ling X Slope (%
	N/A	Land	ling Curb? (Y/N
	N/A	Shar	ed Landing?
PROW/ADA:	N/A	Gutte	er Ponding?
Not Found, R304.5.1	N/A	Gutte	er Lip Ht (in)
	N/A	Paint	ted X Walk1?
		X Wa	alk 1 Direction
		X Wa	alk 1 Width (in)
		X Wa	alk 1 Slone (%)
