Access Compliance Report

Public Rights-of-Way

(Curb Ramps)

Intersection ID: 8157	Main Street: N_TRYON_ST	Cross Street: ORR_RD	Location: NE
ADA ID: B65821D69E9C	Ramp Type: Perp	Initial Pass/Fail: Pass	Overall Compliance: No
Codes/Mitigation Info/Possible Solution		Field Measurements/Component Compliance	
Severity Score: 0.25

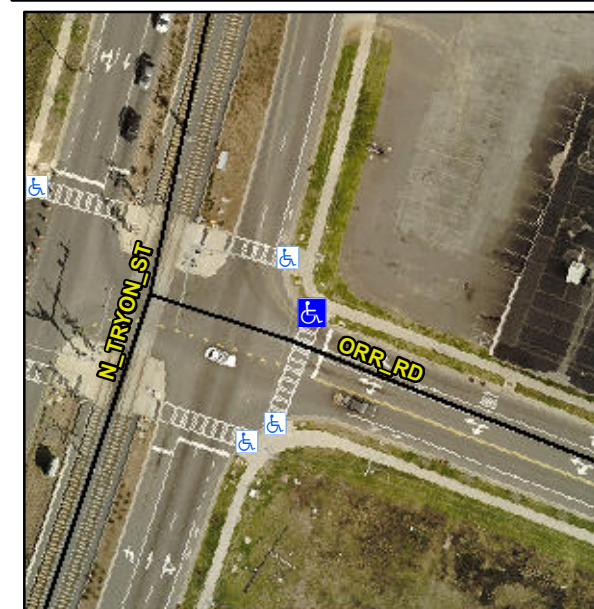
Compliance	Description	Data	Compliance	Description	Data
N/A	Ramp Length (in)	65.0	Yes	Ramp Slope (%)	7.6
Yes	Ramp Width (in)	49.0	Yes	Ramp XSlope (%)	2.3
N/A	Flare Type LT	Sloped	N/A	Flare Type RT	N/A
N/A	Flare Slope LT (%)	6.5	N/A	Flare Slope RT (%)	1.8
N/A	Flare Traversable LT?	No	N/A	Flare Traversable RT?	No
Yes	Landing Length (in)	72.0	Yes	DWS Provided?	Yes
Yes	Landing Width (in)	49.0	Yes	DWS Contrast?	Yes
Yes	Landing Slope (%)	1.8	Yes	DWS Length (in)	24.0
Yes	Landing X Slope (%)	1.8	Yes	DWS Full Width?	Yes
N/A	Landing Curb? (Y/N)	No	Yes	DWS Offset (in)	1.0
N/A	Shared Landing?	No			
Yes	Gutter Ponding?	No	Yes	Gutter Slope (%)	1.5
Yes	Gutter Lip Ht (in)	0.0	Yes	Gutter X Slope (%)	2.6
N/A	Painted X Walk1?	Yes	N/A	Painted X Walk2?	N/A
	X Walk 1 Direction	To S		X Walk 2 Direction	N/A
N/A	X Walk 1 Width (in)	93.0	N/A	X Walk 2 Width (in)	N/A
	X Walk 1 Slope (%)	3.9		X Walk 2 Slope (%)	N/A
	X Walk 1 X Slope (%)	3.0		X Walk 2 X Slope (%)	N/A

Yes	Ramp inside XWalk1?	Yes	N/A	Ramp inside XWalk2?	N/A
	Road Slope (%)	N/A	N/A	Clear Space?	Yes
	Road X Slope (%)	N/A	N/A	Clear Space to XWalk (in)	N/A
Yes	Any Obstructions?	No	Yes	Storm Grate/Utility Hazard?	No
	Obstruction Type			Storm Grate/Utility Type	
			N/A		N/A
			Yes	Surface Condition? (G/P)	Good

Possible Solutions:

Remove & Replace Entire Ramp.
