Access Compliance Report

Public Rights-of-Way

(Curb Ramps)

Intersection ID: 13056	Main Street: S_MINT_ST	Cross Street: W_BLAND_ST	Location: S
ADA ID: B66F23DCA08F	Ramp Type: BlendTrans2	Initial Pass/Fail: Fail	Overall Compliance: No
		Severity Score: 10

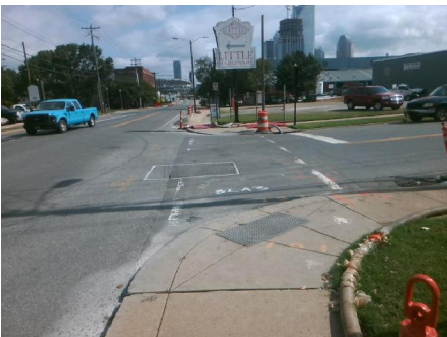
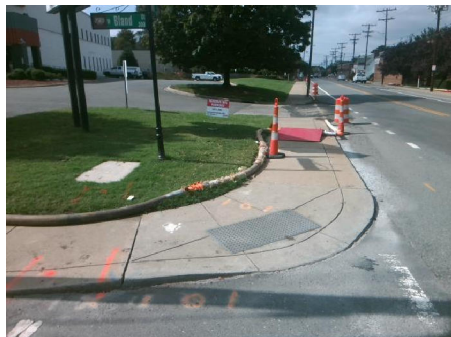
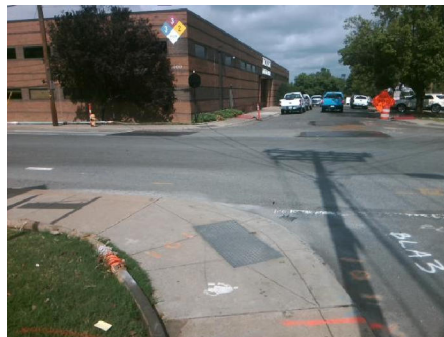
Compliance	Description	Data	Compliance	Description	Data
N/A	Ramp Length (in)	60.0	Yes	BlendTrans Slope (%)	2.9
No	Ramp Width (in)	40.0	No	BlendTrans XSlope (%)	2.2
N/A	Flare Type LT	N/A	N/A	Flare Type RT	N/A
N/A	Flare Slope LT (%)	N/A	N/A	Flare Slope RT (%)	N/A
N/A	Flare Traversable LT?	N/A	N/A	Flare Traversable RT?	N/A
N/A	Landing Length (in)	N/A	N/A	DWS Provided?	N/A
N/A	Landing Width (in)	N/A	N/A	DWS Contrast?	N/A
N/A	Landing Slope (%)	N/A	N/A	DWS Length (in)	N/A
N/A	Landing X Slope (%)	N/A	N/A	DWS Full Width?	N/A
N/A	Landing Curb? (Y/N)	N/A	N/A	DWS Offset (in)	N/A
N/A	Shared Landing?	N/A			
N/A	Gutter Ponding?	N/A	N/A	Gutter Slope (%)	N/A
N/A	Gutter Lip Ht (in)	N/A	N/A	Gutter X Slope (%)	N/A
N/A	Painted X Walk1?	No	N/A	Painted X Walk2?	No
	X Walk 1 Direction	To NE		X Walk 2 Direction	To NW
	X Walk 1 Width (in)	N/A		X Walk 2 Width (in)	N/A
	X Walk 1 Slope (%)	2.7		X Walk 2 Slope (%)	1.6
	X Walk 1 X Slope (%)	0.6		X Walk 2 X Slope (%)	0.7

N/A	Ramp inside XWalk1?	N/A	N/A	Ramp inside XWalk2?	N/A
	Road Slope (%)	0.5		Clear Space?	N/A
	Road X Slope (%)	2.3	N/A	Clear Space to XWalk (in)	N/A
N/A	Any Obstructions?	N/A	N/A	Storm Grate/Utility Hazard?	N/A
	Obstruction Type			Storm Grate/Utility Type	
		N/A			N/A
			Yes	Surface Condition? (G/P)	Good
			N/A	Curb Slope (%)	3.8

Remove & Replace Curb Ramp With Two New Directional Ramps or Equivalent.
