Intersection ID: 17819	Main Street: LYTTLETON_DR	Cross Street: N_SHARON_AMITY_RD	Location:	SW
ADA ID: B67032108ED3	Ramp Type: ParaDiag	Initial Pass/Fail: Fail	Overall Compliance: No	Severity Score: 26.25

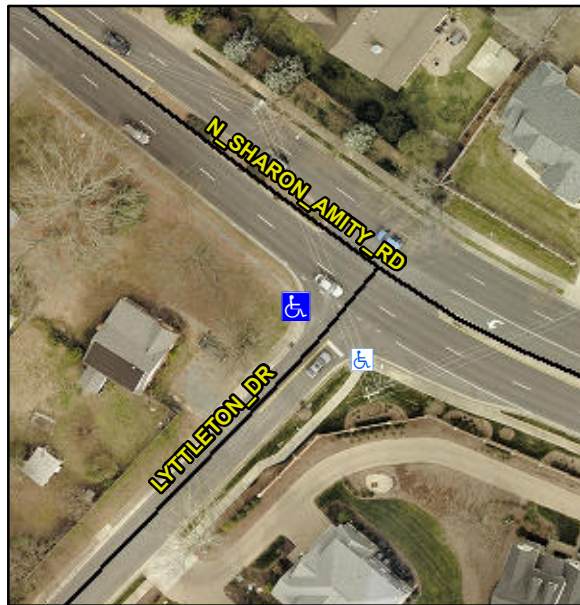
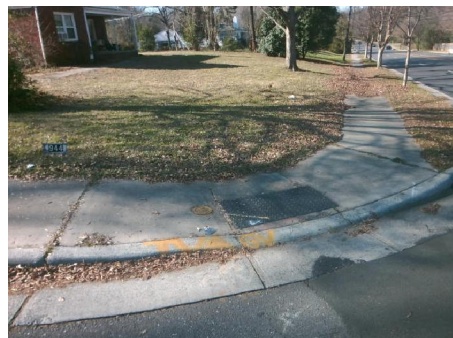
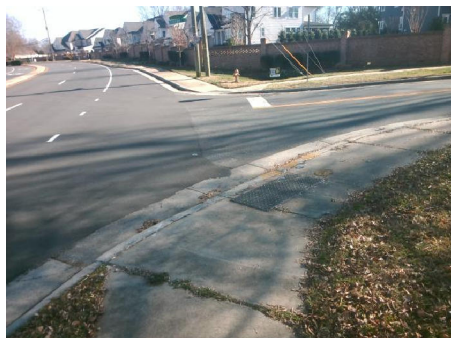
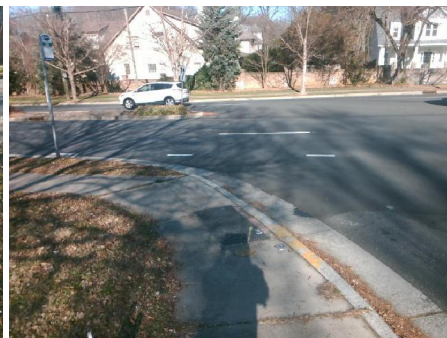
RT RP < 5%

R304.3.2, R304.5.3

Compliance	Description	Data	Compliance	Description	Data
N/A	Ramp Length LT (in)	56.0	N/A	Ramp Length RT (in)	60.0
Yes	Ramp Width LT (in)	56.0	Yes	Ramp Width RT (in)	71.0
No	Ramp Slope LT (%)	14.3	Yes	Ramp Slope RT (%)	1.6
No	Ramp XSlope LT (%)	4.8	No	Ramp XSlope RT (%)	3.0
N/A	Landing Length (in)	N/A	N/A	DWS Provided?	N/A
N/A	Landing Width (in)	N/A	N/A	DWS Contrast?	N/A
N/A	Landing Slope (%)	N/A	N/A	DWS Length (in)	N/A
N/A	Landing X Slope (%)	N/A	N/A	DWS Full Width?	N/A
N/A	Landing Curb? (Y/N)	N/A	N/A	DWS Offset (in)	N/A
N/A	Shared Landing?	N/A			
N/A	Gutter Ponding?	N/A	N/A	Gutter Slope (%)	N/A
N/A	Gutter Lip Ht (in)	N/A	N/A	Gutter X Slope (%)	N/A
N/A	Painted X Walk1?	No	N/A	Painted X Walk2?	No
	X Walk 1 Direction	To SE		X Walk 2 Direction	To NE
N/A	X Walk 1 Width (in)	N/A	N/A	X Walk 2 Width (in)	N/A
	X Walk 1 Slope (%)	0.5		X Walk 2 Slope (%)	1.1
	X Walk 1 X Slope (%)	0.3		X Walk 2 X Slope (%)	2.9
N/A	Ramp inside XWalk1?	N/A	N/A	Ramp inside XWalk2?	N/A

Road Slope (%)	3.2	N/A	Clear Space?	N/A
	Road X Slope (%)	1.6	N/A	Clear Space to XWalk (in)	N/A
N/A	Any Obstructions?	N/A	N/A	Storm Grate/Utility Hazard?	N/A
	Obstruction Type			Storm Grate/Utility Type	
		N/A			N/A
			Yes	Surface Condition? (G/P)	Good
			N/A	Curb Slope (%)	10.7

Remove & Replace Curb Ramp With Two New Directional Ramps or Equivalent.
