Access Compliance Report

Public Rights-of-Way

(Curb Ramps)

Intersection ID: 53229	Main Street: BERRYHILL_RD	Cross Street: MAJOR_SAMUALS_WY	Location: NE
ADA ID: B67CF90638DA	Ramp Type: Perp	Initial Pass/Fail: Fail	Overall Compliance: No
Severity Score: 25			
Codes/Mitigation Info/Possible Solution		Field Measurements/Component Compliance

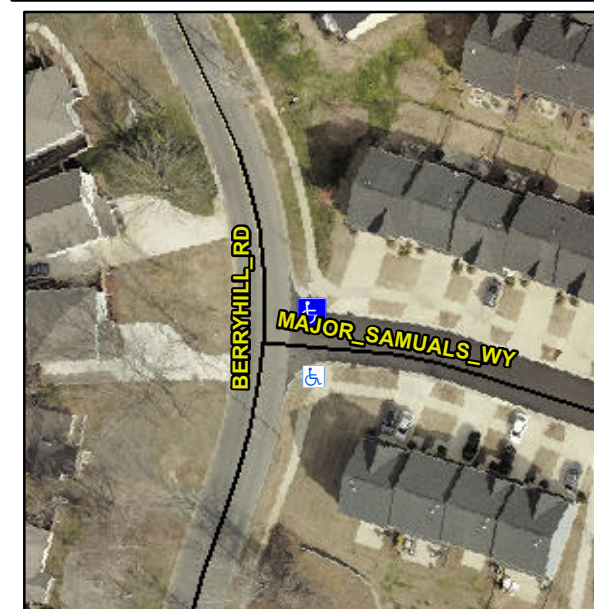
Not Found, R304.2.2, R304.5.3

Compliance	Description	Data	Compliance	Description	Data
N/A	Ramp Length (in)	103.0	No	Ramp Slope (%)	8.6
Yes	Ramp Width (in)	48.0	No	Ramp XSlope (%)	6.6
N/A	Flare Type LT	N/A	N/A	Flare Type RT	N/A
N/A	Flare Slope LT (%)	N/A	N/A	Flare Slope RT (%)	N/A
N/A	Flare Traversable LT?	N/A	N/A	Flare Traversable RT?	N/A
N/A	Landing Length (in)	N/A	N/A	DWS Provided?	N/A
N/A	Landing Width (in)	N/A	N/A	DWS Contrast?	N/A
N/A	Landing Slope (%)	N/A	N/A	DWS Length (in)	N/A
N/A	Landing X Slope (%)	N/A	N/A	DWS Full Width?	N/A
N/A	Landing Curb? (Y/N)	N/A	N/A	DWS Offset (in)	N/A
N/A	Shared Landing?	N/A			
N/A	Gutter Ponding?	N/A	N/A	Gutter Slope (%)	N/A
N/A	Gutter Lip Ht (in)	N/A	N/A	Gutter X Slope (%)	N/A
N/A	Painted X Walk1?	No	N/A	Painted X Walk2?	N/A
	X Walk 1 Direction	To S		X Walk 2 Direction	N/A
N/A	X Walk 1 Width (in)	N/A	N/A	X Walk 2 Width (in)	N/A
	X Walk 1 Slope (%)	0.3		X Walk 2 Slope (%)	N/A
	X Walk 1 X Slope (%)	7.5		X Walk 2 X Slope (%)	N/A

N/A	Ramp inside XWalk1?	N/A	N/A	Ramp inside XWalk2?	N/A
	Road Slope (%)	N/A	N/A	Clear Space?	N/A
	Road X Slope (%)	N/A	N/A	Clear Space to XWalk (in)	N/A
N/A	Any Obstructions?	N/A	N/A	Storm Grate/Utility Hazard?	N/A
	Obstruction Type			Storm Grate/Utility Type	
		N/A			N/A
		Yes		Surface Condition? (G/P)	Good

Remove & Replace Entire Ramp.
