Access Compliance Report Public Rights-of-Way (Curb Ramps)

Intersection ID: 19719 Main Street: BROWN-GRIER_RD Cross Street: CEDAR_HILL_DR Location: SE

ADA ID: B680751D257A Ramp Type: PerpDiag Initial Pass/Fail: Fail Overall Compliance: No Severity Score: 13.75

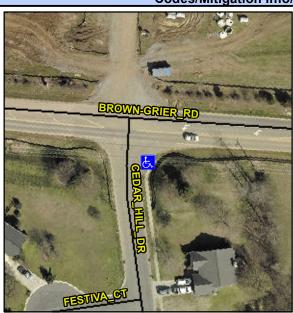
Not Found, R304.2.2, R304.5.3

Fleid Measure	ments/C	ompo	nent Compliance	
Compliance Description		Data	Comp	liance Description	Data
N/A	Ramp Length (in)	52.0	No	Ramp Slope (%)	10.1
Yes	Ramp Width (in)	64.0	No	Ramp XSlope (%)	2.3
N/A	Flare Type LT	N/A	N/A	Flare Type RT	N/A
N/A	Flare Slope LT (%)	N/A	N/A	Flare Slope RT (%)	N/A
N/A	Flare Traversable LT?	N/A	N/A	Flare Traversable RT?	N/A
N/A	Landing Length (in)	N/A	N/A	DWS Provided?	N/A
N/A	Landing Width (in)	N/A	N/A	DWS Contrast?	N/A
N/A	Landing Slope (%)	N/A	N/A	DWS Length (in)	N/A
N/A	Landing X Slope (%)	N/A	N/A	DWS Full Width?	N/A
N/A	Landing Curb? (Y/N)	N/A	N/A	DWS Offset (in)	N/A
N/A	Shared Landing?	N/A			
N/A	Gutter Ponding?	N/A	N/A	Gutter Slope (%)	N/A
N/A	Gutter Lip Ht (in)	1.5	N/A	Gutter X Slope (%)	N/A
N/A	Painted X Walk1?	No	N/A	Painted X Walk2?	No
	X Walk 1 Direction	To N		X Walk 2 Direction	To W
N/A	X Walk 1 Width (in)	N/A	N/A	X Walk 2 Width (in)	N/A
	X Walk 1 Slope (%)	2.8		X Walk 2 Slope (%)	2.1

X Walk 1 X Slope (%)	1.5		X Walk 2 X Slope (%)	1.4
N/A	Ramp inside XWalk1?	N/A	N/A	Ramp inside XWalk2?	N/A
	Road Slope (%)	0.6	N/A	Clear Space?	N/A
	Road X Slope (%)	3.4	N/A	Clear Space to XWalk (in)	N/A
N/A	Any Obstructions?	N/A	N/A	Storm Grate/Utility Hazard?	N/A
	Obstruction Type			Storm Grate/Utility Type	
		N/A			N/A
			Yes	Surface Condition? (G/P)	Good
1-450008-10	10 M	,	-	, ,

Remove & Replace Curb Ramp With
Two New Directional Ramps or
Equivalent.
