Intersection ID: 24573 Main Street: COACHFORD_CT Cross Street: MALLOW_PL Location: E

ADA ID: B68954E29B96 Ramp Type: PerpDiag Initial Pass/Fail: Pass Overall Compliance: No Severity Score: 7.5

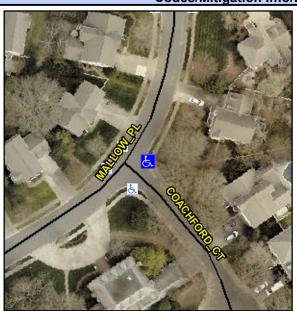
Not Found, R304.2.2-Perp, R304.3.2-Para, R305.1.4, R305.2, R304.5.4

i ieiu ivieasui	ememo/C	onipo	Hent Compliance	
Compliance Description		Data	Data Compliance Description		Data
N/A	Ramp Length (in)	46.0	Yes	Ramp Slope (%)	6.3
Yes	Ramp Width (in)	48.0	Yes	Ramp XSlope (%)	0.4
N/A	Flare Type LT	Sloped	N/A	Flare Type RT	N/A
N/A	Flare Slope LT (%)	7.1	Yes	Flare Slope RT (%)	5.2
N/A	Flare Traversable LT?	Yes	N/A	Flare Traversable RT?	Yes
Yes	Landing Length (in)	54.0	Yes	DWS Provided?	Yes
Yes	Landing Width (in)	48.0	Yes	DWS Contrast?	Yes
No	Landing Slope (%)	3.7	Yes	DWS Length (in)	24.0
Yes	Landing X Slope (%)	0.4	No	DWS Full Width?	No
N/A	Landing Curb? (Y/N)	No	No	DWS Offset (in)	3.0
N/A	Shared Landing?	No			
Yes	Gutter Ponding?	No	No	Gutter Slope (%)	10.0
Yes	Gutter Lip Ht (in)	0.0	Yes	Gutter X Slope (%)	0.8
N/A	Painted X Walk1?	No	N/A	Painted X Walk2?	No
	X Walk 1 Direction	To NW		X Walk 2 Direction	To SW
N/A	X Walk 1 Width (in)	N/A	N/A	X Walk 2 Width (in)	N/A
	X Walk 1 Slope (%)	2.0		X Walk 2 Slope (%)	2.3

X Walk 1 X Slope (%)	1.5		X Walk 2 X Slope (%)	0.4
N/A	Ramp inside XWalk1?	N/A	N/A	Ramp inside XWalk2?	N/A
	Road Slope (%)	0.7	N/A	Clear Space?	Yes
	Road X Slope (%)	3.3	N/A	Clear Space to XWalk (in)	N/A
Yes	Any Obstructions?	No	Yes	Storm Grate/Utility Hazard?	No
	Obstruction Type			Storm Grate/Utility Type

Remove & Replace Curb Ramp With Two New Directional Ramps or Equivalent. Remove & Replace Gutter.
