Access Compliance Report

Public Rights-of-Way

(Curb Ramps)

Intersection ID: 21972	Main Street: ENGLAND_ST	Cross Street: PENINSULA_LN	Location: SW
ADA ID: B6B11B431BD6	Ramp Type: PerpDiag	Initial Pass/Fail: Fail	Overall Compliance: No
Severity Score: 12.5			
Codes/Mitigation Info/Possible Solution		Field Measurements/Component Compliance

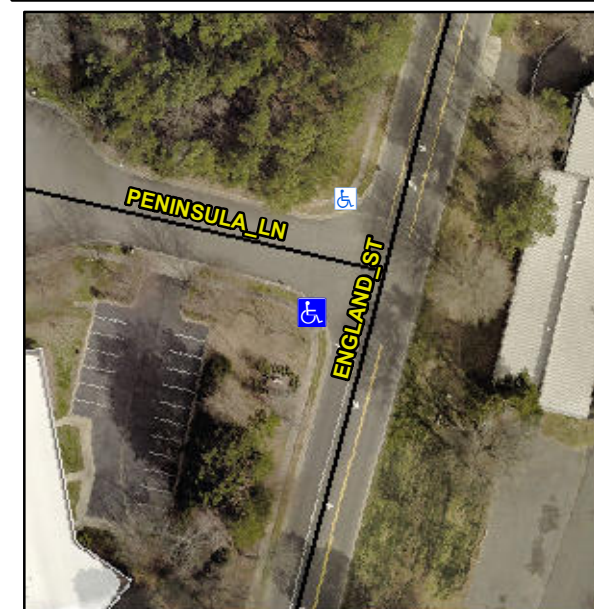
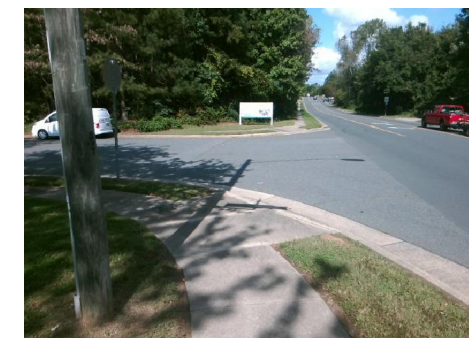
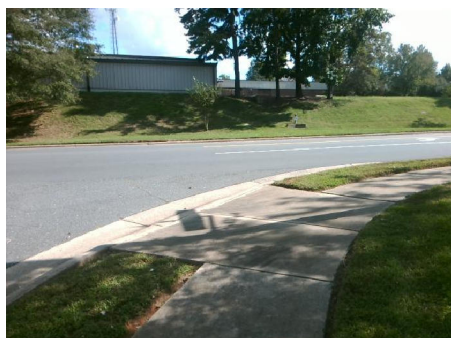
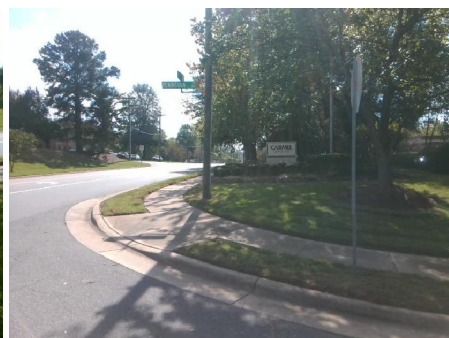
Not Found, R304.5.3

Compliance	Description	Data	Compliance	Description	Data
N/A	Ramp Length (in)	95.0	Yes	Ramp Slope (%)	7.2
Yes	Ramp Width (in)	48.0	No	Ramp XSlope (%)	6.6
N/A	Flare Type LT	N/A	N/A	Flare Type RT	N/A
N/A	Flare Slope LT (%)	N/A	N/A	Flare Slope RT (%)	N/A
N/A	Flare Traversable LT?	N/A	N/A	Flare Traversable RT?	N/A
N/A	Landing Length (in)	N/A	N/A	DWS Provided?	N/A
N/A	Landing Width (in)	N/A	N/A	DWS Contrast?	N/A
N/A	Landing Slope (%)	N/A	N/A	DWS Length (in)	N/A
N/A	Landing X Slope (%)	N/A	N/A	DWS Full Width?	N/A
N/A	Landing Curb? (Y/N)	N/A	N/A	DWS Offset (in)	N/A
N/A	Shared Landing?	N/A			
N/A	Gutter Ponding?	N/A	N/A	Gutter Slope (%)	N/A
N/A	Gutter Lip Ht (in)	N/A	N/A	Gutter X Slope (%)	N/A
N/A	Painted X Walk1?	No	N/A	Painted X Walk2?	No
	X Walk 1 Direction	To SE		X Walk 2 Direction	To NE
N/A	X Walk 1 Width (in)	N/A	N/A	X Walk 2 Width (in)	N/A
	X Walk 1 Slope (%)	5.4		X Walk 2 Slope (%)	0.2
	X Walk 1 X Slope (%)	1.0		X Walk 2 X Slope (%)	8.2

N/A	Ramp inside XWalk1?	N/A	N/A	Ramp inside XWalk2?	N/A
	Road Slope (%)	4.4	N/A	Clear Space?	N/A
	Road X Slope (%)	4.8	N/A	Clear Space to XWalk (in)	N/A
N/A	Any Obstructions?	N/A	N/A	Storm Grate/Utility Hazard?	N/A
	Obstruction Type			Storm Grate/Utility Type	
		N/A			N/A
			Yes	Surface Condition? (G/P)	Good

Remove & Replace Curb Ramp With Two New Directional Ramps or Equivalent.

Total Cost: \$ 3200.00
