Access Compliance Report

Public Rights-of-Way

(Curb Ramps)

| Intersection ID: 12355 | Main Street: MONUMENT_ST | Cross Street: GREENLAND_AV | Location: SE |

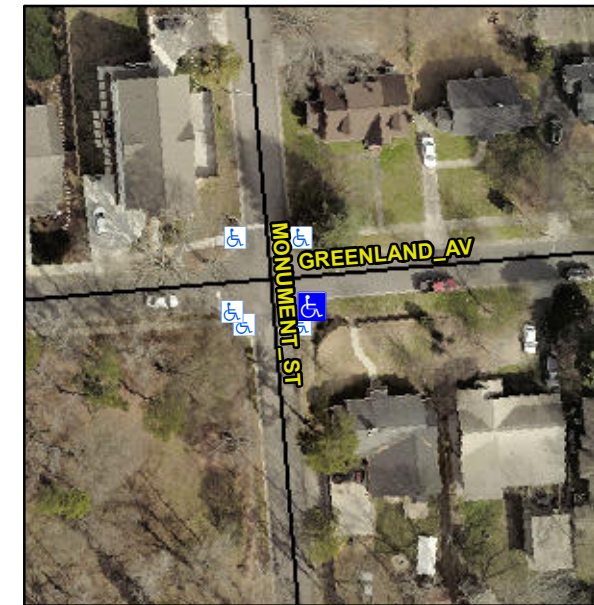
| ADA ID: B6B1EDF1D8C1 | Ramp Type: Perp | Initial Pass/Fail: Fail | Overall Compliance: No |

Not Found, R304.5.3

| Compliance | Description | Data | Compliance | Description | Data |
|---|---|---|---|---|---|
| Yes | Ramp Width (in) | 48.0 | No | Ramp XSlope (%) | 7.2 |

Remove & Replace Entire Ramp.
