# Access Compliance Report

## Public Rights-of-Way

### (Curb Ramps)

Intersection ID: 29144	Main Street: DEATON_HILL_DR	Cross Street: HUNTERS_CREEK_CT	Location: NE
ADA ID: B6B50C2706CF	Ramp Type: BlendTrans1	Initial Pass/Fail: Fail	Overall Compliance: No
		Severity Score: 8.75

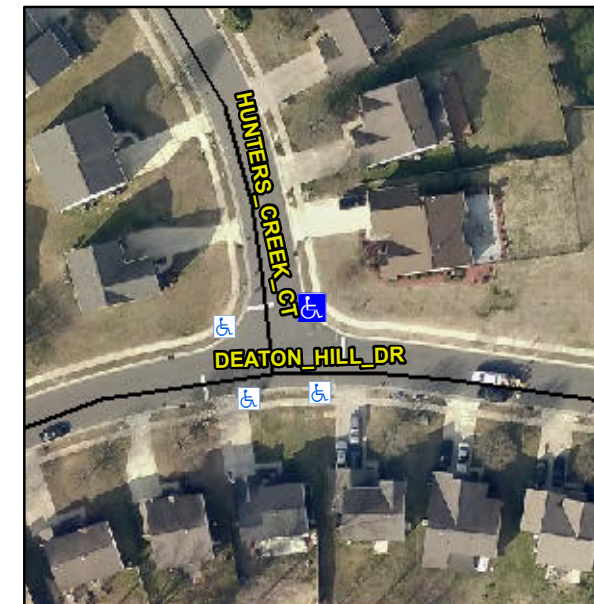
**Not Found, R304.5.1**

Compliance	Description	Data	Compliance	Description	Data
N/A	Ramp Length (in)	47.0	Yes	BlendTrans Slope (%)	4.3
No	Ramp Width (in)	47.0	Yes	BlendTrans XSlope (%)	1.5
N/A	Flare Type LT	N/A	N/A	Flare Type RT	N/A
N/A	Flare Slope LT (%)	N/A	N/A	Flare Slope RT (%)	N/A
N/A	Flare Traversable LT?	N/A	N/A	Flare Traversable RT?	N/A
N/A	Landing Length (in)	N/A	N/A	DWS Provided?	N/A
N/A	Landing Width (in)	N/A	N/A	DWS Contrast?	N/A
N/A	Landing Slope (%)	N/A	N/A	DWS Length (in)	N/A
N/A	Landing X Slope (%)	N/A	N/A	DWS Full Width?	N/A
N/A	Landing Curb? (Y/N)	N/A	N/A	DWS Offset (in)	N/A
N/A	Shared Landing?	N/A			
N/A	Gutter Ponding?	N/A	N/A	Gutter Slope (%)	N/A
N/A	Gutter Lip Ht (in)	N/A	N/A	Gutter X Slope (%)	N/A
N/A	Painted X Walk1?	No	N/A	Painted X Walk2?	No
	X Walk 1 Direction	To W		X Walk 2 Direction	To S
	X Walk 1 Width (in)	N/A		X Walk 2 Width (in)	N/A
	X Walk 1 Slope (%)	5.3		X Walk 2 Slope (%)	3.1
	X Walk 1 X Slope (%)	3.5		X Walk 2 X Slope (%)	3.1

N/A	Ramp inside XWalk1?	N/A	N/A	Ramp inside XWalk2?	N/A
	Road Slope (%)	2.2		Clear Space?	N/A
	Road X Slope (%)	5.0	N/A	Clear Space to XWalk (in)	N/A
N/A	Any Obstructions?	N/A	N/A	Storm Grate/Utility Hazard?	N/A
	Obstruction Type			Storm Grate/Utility Type	
		N/A			N/A
			Yes	Surface Condition? (G/P)	Good
			No	Curb Slope (%)	13.3

**Remove & Replace Curb Ramp With Two New Directional Ramps or Equivalent.**
