Access Compliance Report

Public Rights-of-Way

(Curb Ramps)

Intersection ID: 27872	Main Street: BALLANTYNE_COUNTRY_CLUB_DR	Cross Street: LETHCO_WY	Location: SE
ADA ID: B6B50C6A8DF6	Ramp Type: Perp	Initial Pass/Fail: Fail	Overall Compliance: No
Severity Score: 33.75			
Codes/Mitigation Info/Possible Solution		Field Measurements/Component Compliance

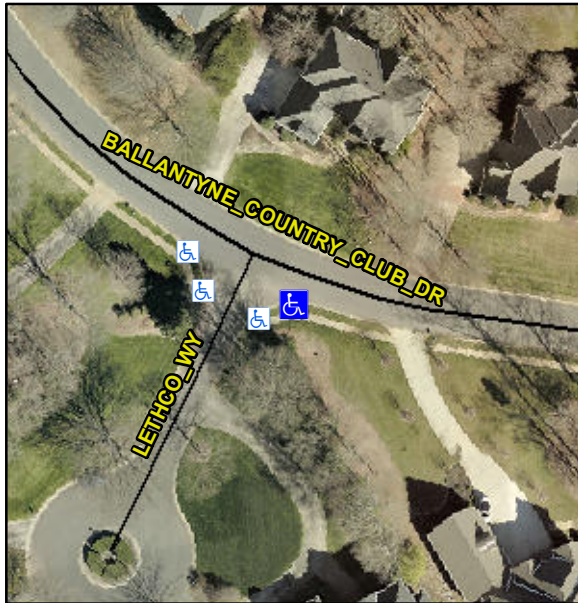
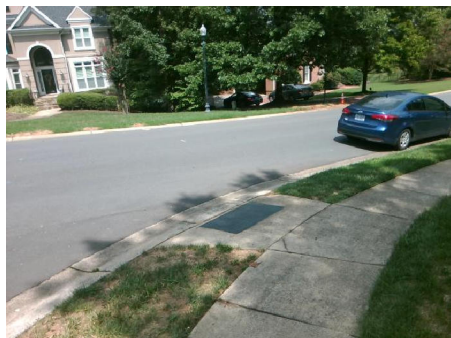
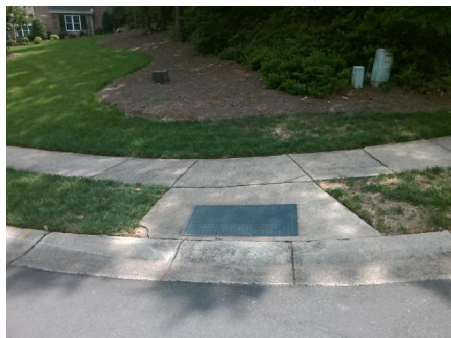
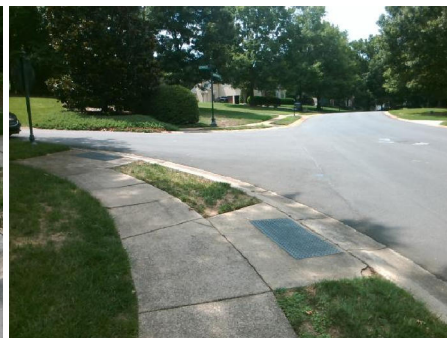
Not Found, R304.5.1, R304.5.3

Compliance	Description	Data	Compliance	Description	Data
N/A	Ramp Length (in)	48.0	Yes	Ramp Slope (%)	6.3
No	Ramp Width (in)	43.0	No	Ramp XSlope (%)	10.5
N/A	Flare Type LT	N/A	N/A	Flare Type RT	N/A
N/A	Flare Slope LT (%)	N/A	N/A	Flare Slope RT (%)	N/A
N/A	Flare Traversable LT?	N/A	N/A	Flare Traversable RT?	N/A
N/A	Landing Length (in)	N/A	N/A	DWS Provided?	N/A
N/A	Landing Width (in)	N/A	N/A	DWS Contrast?	N/A
N/A	Landing Slope (%)	N/A	N/A	DWS Length (in)	N/A
N/A	Landing X Slope (%)	N/A	N/A	DWS Full Width?	N/A
N/A	Landing Curb? (Y/N)	N/A	N/A	DWS Offset (in)	N/A
N/A	Shared Landing?	N/A			
N/A	Gutter Ponding?	N/A	N/A	Gutter Slope (%)	N/A
N/A	Gutter Lip Ht (in)	N/A	N/A	Gutter X Slope (%)	N/A
N/A	Painted X Walk1?	No	N/A	Painted X Walk2?	N/A
	X Walk 1 Direction	To NE		X Walk 2 Direction	N/A
N/A	X Walk 1 Width (in)	N/A	N/A	X Walk 2 Width (in)	N/A
	X Walk 1 Slope (%)	4.0		X Walk 2 Slope (%)	N/A
	X Walk 1 X Slope (%)	10.2		X Walk 2 X Slope (%)	N/A

N/A	Ramp inside XWalk1?	N/A	N/A	Ramp inside XWalk2?	N/A
	Road Slope (%)	N/A	N/A	Clear Space?	N/A
	Road X Slope (%)	N/A	N/A	Clear Space to XWalk (in)	N/A
N/A	Any Obstructions?	N/A	N/A	Storm Grate/Utility Hazard?	N/A
	Obstruction Type			Storm Grate/Utility Type	
		N/A			N/A
			Yes	Surface Condition? (G/P)	Good

Possible Solutions:

Remove & Replace Entire Ramp.

Total Cost: \$ **1850.00**
