Intersection ID: 42785	Main Street: CALDWELL_RD	Cross Street: OLD_STONE_CROSSING_DR	Location:	E
ADA ID: B6B55F72D6A4	Ramp Type: Combination1	Initial Pass/Fail: Fail	Overall Compliance: No	Severity Score: 13.75

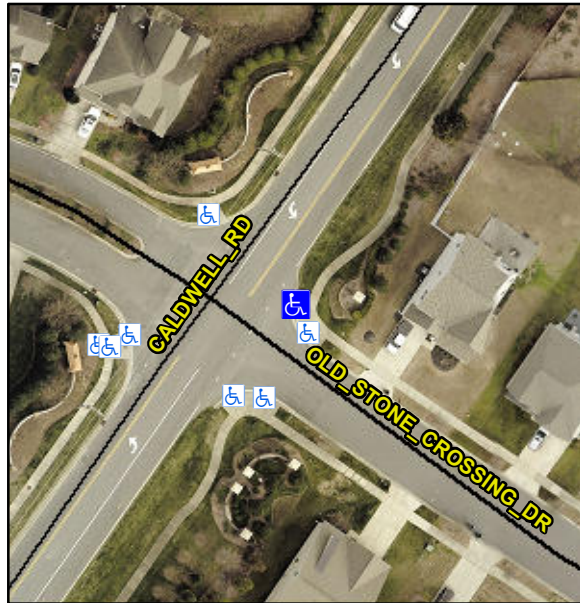
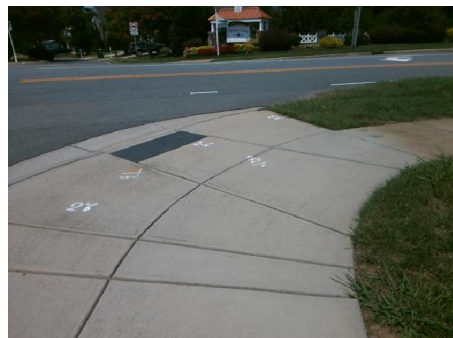
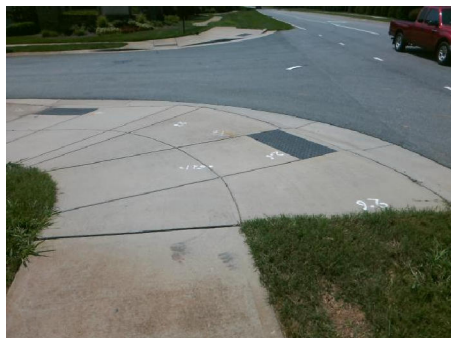
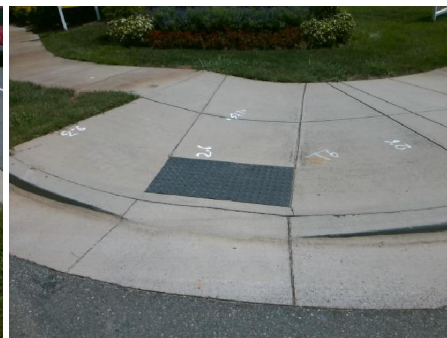
Not Found, R304.5.3, R304.3.2

Possible Solutions:			Compliance	Description	Data	Compliance	Description	Data
Remove & Replace Entire Ramp.			N/A	Ramp Length LT (in)	14.0	N/A	Ramp Length RT (in)	13.0
			Yes	Ramp Width LT (in)	58.0	Yes	Ramp Width RT (in)	60.0
			No	Ramp Slope LT (%)	8.5	Yes	Ramp Slope RT (%)	5.8
			Yes	Ramp XSlope LT (%)	0.9	Yes	Ramp XSlope RT (%)	0.0
			N/A	Ramp Length (in)	71.5	Yes	Ramp Slope (%)	0.4
			Yes	Ramp Width (in)	48.0	No	Ramp XSlope (%)	4.8
Surveyor Notes: N/A			N/A	Flare Type LT	N/A	N/A	Flare Type RT	N/A
			N/A	Flare Slope LT (%)	N/A	N/A	Flare Slope RT (%)	N/A
			N/A	Flare Traversable LT?	N/A	N/A	Flare Traversable RT?	N/A
			N/A	Landing Length (in)	N/A	N/A	DWS Provided?	N/A
			N/A	Landing Width (in)	N/A	N/A	DWS Contrast?	N/A
			N/A	Landing Slope (%)	N/A	N/A	DWS Length (in)	N/A
PROW/ADA: Not Found, R304.5.3, R304.3.2			N/A	Landing X Slope (%)	N/A	N/A	DWS Full Width?	N/A
			N/A	Landing Curb? (Y/N)	N/A	N/A	DWS Offset (in)	N/A

N/A	Shared Landing?	N/A			
			N/A	Gutter Ponding?	N/A	N/A	Gutter Slope (%)	N/A
			N/A	Gutter Lip Ht (in)	N/A	N/A	Gutter X Slope (%)	N/A
			N/A	Painted X Walk1?	No	N/A	Painted X Walk2?	N/A
				X Walk 1 Direction	To NW		X Walk 2 Direction	N/A
				X Walk 1 Width (in)	N/A		X Walk 2 Width (in)	N/A
				X Walk 1 Slope (%)	3.6		X Walk 2 Slope (%)	N/A
				X Walk 1 X Slope (%)	0.9		X Walk 2 X Slope (%)	N/A
Total Cost: \$ 1800.00			N/A	Ramp inside XWalk1?	N/A	N/A	Ramp inside XWalk2?	N/A
				Road Slope (%)	N/A		Clear Space?	N/A
				Road X Slope (%)	N/A	N/A	Clear Space to XWalk (in)	N/A

Compliance	Description	Data
N/A	Ramp Length RT (in)	13.0
Yes	Ramp Width RT (in)	60.0
Yes	Ramp Slope RT (%)	5.8
Yes	Ramp XSlope RT (%)	0.0
Yes	Ramp Slope (%)	0.4
No	Ramp XSlope (%)	4.8
N/A	Flare Type RT	N/A
N/A	Flare Slope RT (%)	N/A
N/A	Flare Traversable RT?	N/A
N/A	DWS Provided?	N/A
N/A	DWS Contrast?	N/A
N/A	DWS Length (in)	N/A
N/A	DWS Full Width?	N/A
N/A	DWS Offset (in)	N/A
N/A	Gutter Slope (%)	N/A
N/A	Gutter X Slope (%)	N/A
N/A	Painted X Walk2?	N/A
N/A	X Walk 2 Direction	N/A
N/A	X Walk 2 Width (in)	N/A
N/A	X Walk 2 Slope (%)	N/A
N/A	X Walk 2 X Slope (%)	N/A
N/A	Ramp inside XWalk2?	N/A
N/A	Clear Space?	N/A
N/A	Clear Space to XWalk (in)	N/A
N/A	Any Obstruction?	N/A
N/A	Obstruction Type	N/A
N/A	Storm Grate/Utility Hazard?	N/A
N/A	Storm Grate/Utility Type	N/A
Yes	Surface Condition? (G/P)	Good
Yes	Curb Slope (%)	11.9

Possible Solutions:

Remove & Replace Entire Ramp.

Total Cost: \$ 1800.00
