Access Compliance Report

Public Rights-of-Way

(Curb Ramps)

Intersection ID: N/A	Main Street: TRYON_ST	Cross Street: PARKAIRE_LN	Location: NW
ADA ID: B6B8B883C5F5	Ramp Type: Directional1	Initial Pass/Fail: Fail	Overall Compliance: No
Severity Score: 12.5			
Codes/Mitigation Info/Possible Solution		Field Measurements/Component Compliance

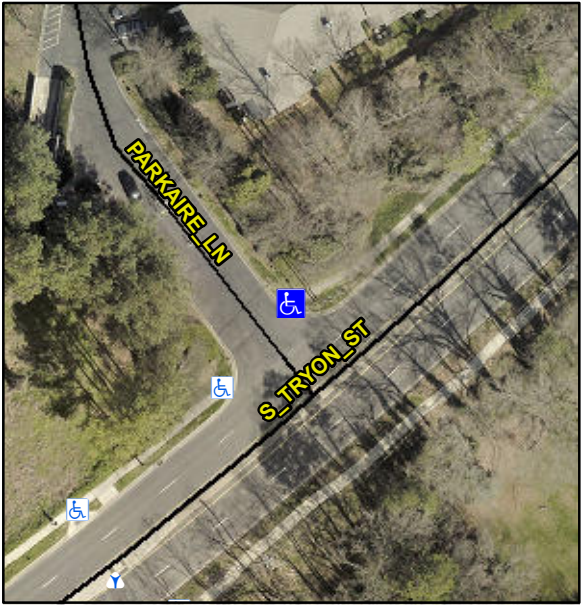
Possible Solutions:						
	Remove & Replace Entire Ramp.						
	Surveyor Notes: N/A	Compliance	Description	Data	Compliance	Description	Data
		N/A	Ramp Length (in)	62.0	N/A	Grade Break?	N/A
		Yes	Ramp Width (in)	60.0	N/A	Grade Break Slope (%)	0.0
		Yes	Ramp Slope (%)	7.7	N/A	Grade Break XSlope (%)	0.0
		No	Ramp XSlope (%)	6.2			
		N/A	Flare Type LT	N/A	N/A	Flare Type RT	N/A
		N/A	Flare Slope LT (%)	N/A	N/A	Flare Slope RT (%)	0.0
		N/A	Flare Traversable LT?	N/A	N/A	Flare Traversable RT?	N/A
		N/A	Landing Length (in)	0.0	N/A	DWS Provided?	N/A
		N/A	Landing Width (in)	0.0	N/A	DWS Contrast?	N/A
	PROW/ADA: R304.5.3	N/A	Landing Slope (%)	0.0	N/A	DWS Length (in)	N/A
		N/A	Landing X Slope (%)	0.0	N/A	DWS Full Width?	N/A
		N/A	Landing Curb? (Y/N)	N/A	N/A	DWS Offset LT (in)	N/A
		N/A	Shared Landing?	N/A	N/A	DWS Offset RT (in)	N/A
		N/A	Gutter Ponding?	0.0	N/A	Gutter Slope (%)	N/A
		N/A	Gutter Lip Ht (in)	0.0	N/A	Gutter X Slope (%)	N/A

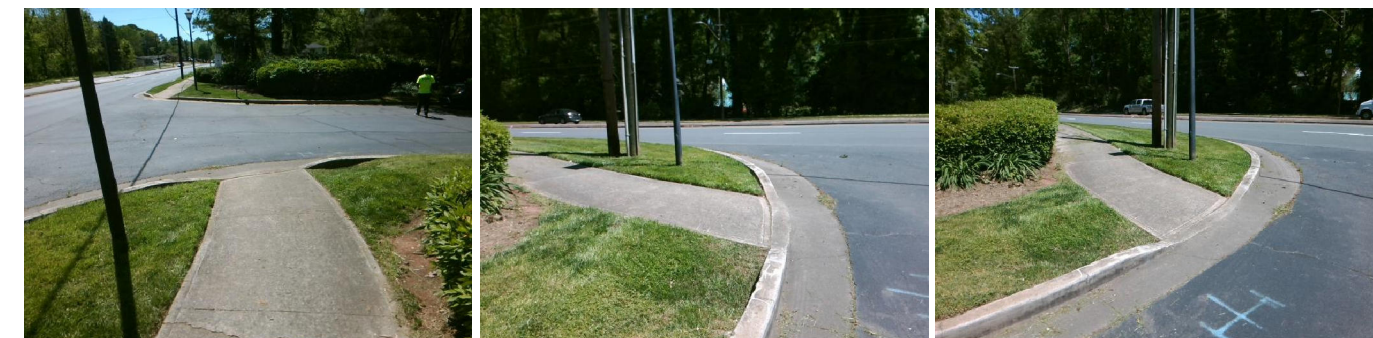
N/A	Painted X Walk1?	No		Road Slope (%)	6.0
			X Walk 1 Direction	To SW		Road X Slope (%)	6.5
			X Walk 1 Width (in)	N/A		Clear Space?	N/A
			X Walk 1 Slope (%)	6.0	N/A	Clear Space to XWalk (in)	N/A
			X Walk 1 X Slope (%)	6.5	N/A	Storm Grate/Utility Hazard?	N/A
		N/A	Ramp inside XWalk1?	N/A		Storm Grate/Utility Type	
		N/A	Any Obstructions?	N/A			N/A
			Obstruction Type		Yes	Surface Condition? (G/P)	Good
					N/A	Curb Slope (%)	0.6
	Total Cost:	\$	1600.00
