# Access Compliance Report

## Public Rights-of-Way

### (Curb Ramps)

Intersection ID: 15799	Main Street: MARION_PL	Cross Street: MELBOURNE_CT	Location: E
ADA ID: B6BEE0A494A0	Ramp Type: PerpDiag	Initial Pass/Fail: Fail	Overall Compliance: No
Severity Score: 1.25			
Codes/Mitigation Info/Possible Solution		Field Measurements/Component Compliance

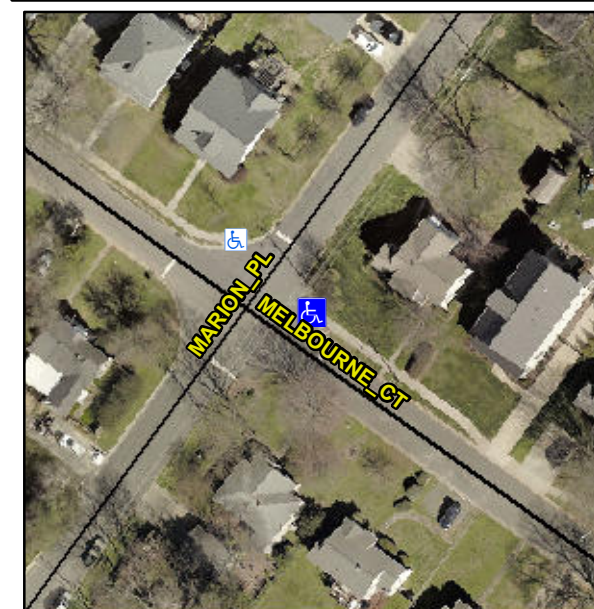
**Not Found, R304.5.3**

Compliance	Description	Data	Compliance	Description	Data
N/A	Ramp Length (in)	31.0	Yes	Ramp Slope (%)	5.1
Yes	Ramp Width (in)	48.0	No	Ramp XSlope (%)	2.3
N/A	Flare Type LT	N/A	N/A	Flare Type RT	N/A
N/A	Flare Slope LT (%)	N/A	N/A	Flare Slope RT (%)	N/A
N/A	Flare Traversable LT?	N/A	N/A	Flare Traversable RT?	N/A
N/A	Landing Length (in)	N/A	N/A	DWS Provided?	N/A
N/A	Landing Width (in)	N/A	N/A	DWS Contrast?	N/A
N/A	Landing Slope (%)	N/A	N/A	DWS Length (in)	N/A
N/A	Landing X Slope (%)	N/A	N/A	DWS Full Width?	N/A
N/A	Landing Curb? (Y/N)	N/A	N/A	DWS Offset (in)	N/A
N/A	Shared Landing?	N/A			
N/A	Gutter Ponding?	N/A	N/A	Gutter Slope (%)	N/A
N/A	Gutter Lip Ht (in)	N/A	N/A	Gutter X Slope (%)	N/A
N/A	Painted X Walk1?	No	N/A	Painted X Walk2?	No
	X Walk 1 Direction	To NW		X Walk 2 Direction	To SW
N/A	X Walk 1 Width (in)	N/A	N/A	X Walk 2 Width (in)	N/A
	X Walk 1 Slope (%)	1.9		X Walk 2 Slope (%)	1.0
	X Walk 1 X Slope (%)	1.1		X Walk 2 X Slope (%)	0.6

N/A	Ramp inside XWalk1?	N/A	N/A	Ramp inside XWalk2?	N/A
	Road Slope (%)	0.7	N/A	Clear Space?	N/A
	Road X Slope (%)	0.9	N/A	Clear Space to XWalk (in)	N/A
N/A	Any Obstructions?	N/A	N/A	Storm Grate/Utility Hazard?	N/A
	Obstruction Type			Storm Grate/Utility Type	
		N/A			N/A
		Yes		Surface Condition? (G/P)	Good

Possible Solutions:

**Remove & Replace Curb Ramp With Two New Directional Ramps or Equivalent.**
