# Access Compliance Report

## Public Rights-of-Way

### (Curb Ramps)

| Intersection ID: 31445 | Main Street: RIDING_HILL_AV | Cross Street: UNDERWOOD_AV | Location: S |

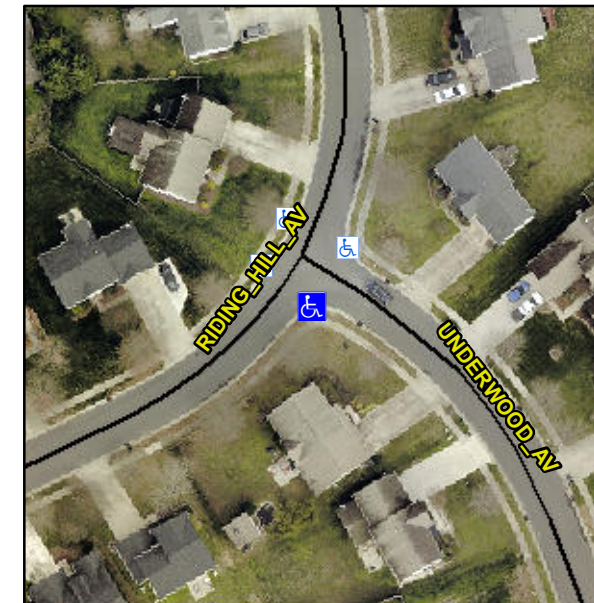
**Not Found, R304.2.2, R304.5.3**

| Compliance | Description | Data | Compliance | Description | Data |
|---|---|---|---|---|---|
| N/A | Ramp Length (in) | 63.0 | No | Ramp Slope (%) | 8.7 |
| Yes | Ramp Width (in) | 48.0 | No | Ramp XSlope (%) | 3.7 |

**Remove & Replace Curb Ramp With Two New Directional Ramps or Equivalent.**

Total Cost: \$ 3200.00
