Access Compliance Report

Public Rights-of-Way

(Curb Ramps)

Intersection ID: 54325	Main Street: CANTERBURY CASTLE DR	Cross Street: ROCKY HILL CASTLE DR	Location: NW
ADA ID: B6C55AC4E66B	Ramp Type: Perp	Initial Pass/Fail: Fail	Overall Compliance: No
Severity Score: 21.25			
Codes/Mitigation Info/Possible Solution		Field Measurements/Component Compliance

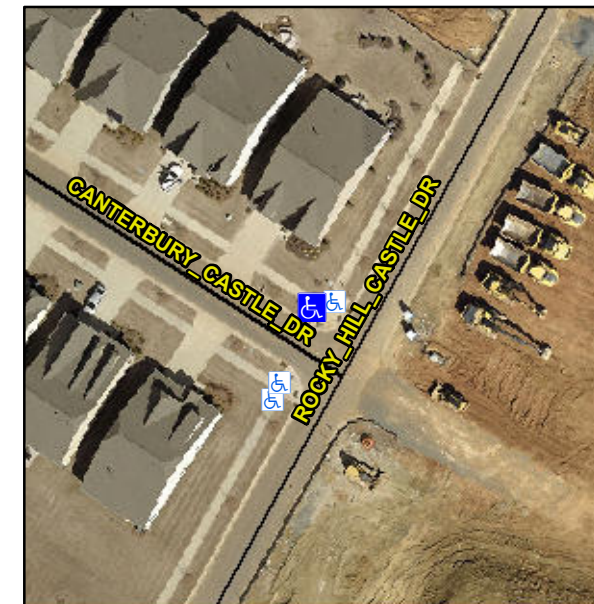
Compliance	Description	Data	Compliance	Description	Data
N/A	Ramp Length (in)	108.0	No	Ramp Slope (%)	9.6
No	Ramp Width (in)	47.0	Yes	Ramp XSlope (%)	0.7
N/A	Flare Type LT	N/A	N/A	Flare Type RT	N/A
N/A	Flare Slope LT (%)	N/A	N/A	Flare Slope RT (%)	N/A
N/A	Flare Traversable LT?	N/A	N/A	Flare Traversable RT?	N/A
N/A	Landing Length (in)	N/A	N/A	DWS Provided?	N/A
N/A	Landing Width (in)	N/A	N/A	DWS Contrast?	N/A
N/A	Landing Slope (%)	N/A	N/A	DWS Length (in)	N/A
N/A	Landing X Slope (%)	N/A	N/A	DWS Full Width?	N/A
N/A	Landing Curb? (Y/N)	N/A	N/A	DWS Offset (in)	N/A
N/A	Shared Landing?	N/A			
N/A	Gutter Ponding?	N/A	N/A	Gutter Slope (%)	N/A
N/A	Gutter Lip Ht (in)	1.0	N/A	Gutter X Slope (%)	N/A
N/A	Painted X Walk1?	No	N/A	Painted X Walk2?	N/A
	X Walk 1 Direction	To SW		X Walk 2 Direction	N/A
N/A	X Walk 1 Width (in)	N/A	N/A	X Walk 2 Width (in)	N/A
	X Walk 1 Slope (%)	0.7		X Walk 2 Slope (%)	N/A
	X Walk 1 X Slope (%)	3.3		X Walk 2 X Slope (%)	N/A

N/A	Ramp inside XWalk1?	N/A	N/A	Ramp inside XWalk2?	N/A
	Road Slope (%)	N/A	N/A	Clear Space?	N/A
	Road X Slope (%)	N/A	N/A	Clear Space to XWalk (in)	N/A
N/A	Any Obstructions?	N/A	N/A	Storm Grate/Utility Hazard?	N/A
	Obstruction Type			Storm Grate/Utility Type	
		N/A			N/A
			Yes	Surface Condition? (G/P)	Good

Possible Solutions:

Remove & Replace Entire Ramp.

Not Found, R304.5.1, R304.2.2
