Access Compliance Report

Public Rights-of-Way

(Curb Ramps)

Intersection ID: N/A	Main Street: SOUTHSTREAM_BV	Cross Street: N/A	Location: S
ADA ID: B6D2FC79EDA2	Ramp Type: PerpDiag	Initial Pass/Fail: Fail	Overall Compliance: No
Codes/Mitigation Info/Possible Solution		Field Measurements/Component Compliance	
Severity Score: 13.75

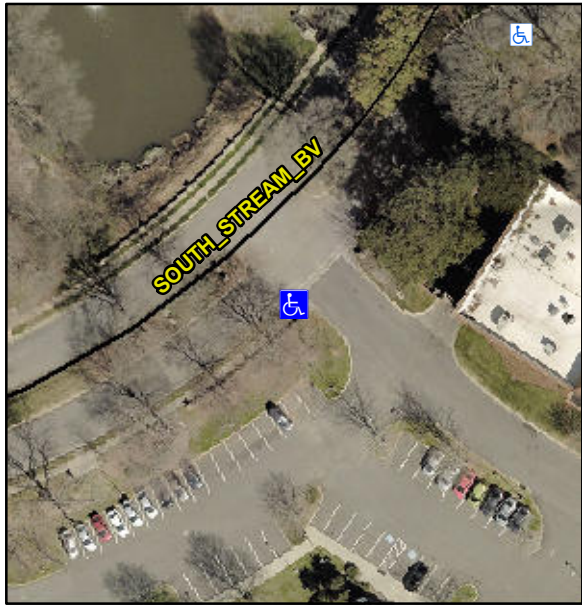
Possible Solutions:		Compliance		Description	Data	Compliance		Description	Data
	Remove & Replace Curb Ramp With Two New Directional Ramps or Equivalent.		N/A	Ramp Length (in)	51.0	No	Ramp Slope (%)	9.1		
			Yes	Ramp Width (in)	48.0	No	Ramp XSlope (%)	2.3		
			N/A	Flare Type LT	N/A	N/A	Flare Type RT	N/A		
			N/A	Flare Slope LT (%)	N/A	N/A	Flare Slope RT (%)	N/A		
			N/A	Flare Traversable LT?	No	N/A	Flare Traversable RT?	No		
			N/A	Landing Length (in)	N/A	N/A	DWS Provided?	N/A		
			N/A	Landing Width (in)	N/A	N/A	DWS Contrast?	N/A		
			N/A	Landing Slope (%)	N/A	N/A	DWS Length (in)	N/A		
			N/A	Landing X Slope (%)	N/A	N/A	DWS Full Width?	N/A		
Surveyor Notes:		N/A	N/A	Landing Curb? (Y/N)	N/A	N/A	DWS Offset (in)	N/A		
		N/A	Shared Landing?	N/A						
		N/A	Gutter Ponding?	N/A	N/A	Gutter Slope (%)	N/A			
		N/A	Gutter Lip Ht (in)	N/A	N/A	Gutter X Slope (%)	N/A			
		N/A	Painted X Walk1?	No	N/A	Painted X Walk2?	No

X Walk 1 Direction	To NE		X Walk 2 Direction	To NW			
		N/A	X Walk 1 Width (in)	N/A	N/A	X Walk 2 Width (in)	N/A			
			X Walk 1 Slope (%)	0.5		X Walk 2 Slope (%)	4.8			
			X Walk 1 X Slope (%)	3.3		X Walk 2 X Slope (%)	0.1			
		N/A	Ramp inside XWalk1?	N/A	N/A	Ramp inside XWalk2?	N/A			
			Road Slope (%)	1.3	N/A	Clear Space?	N/A			
			Road X Slope (%)	1.7	N/A	Clear Space to XWalk (in)	N/A			
		N/A	Any Obstructions?	N/A	N/A	Storm Grate/Utility Hazard?	N/A			
			Obstruction Type			Storm Grate/Utility Type				
					N/A		N/A			
					Yes	Surface Condition? (G/P)	Good
