Access Compliance Report

Public Rights-of-Way

(Curb Ramps)

Intersection ID: 5606	Main Street: JOHN_KIRK_DR	Cross Street: CAMERON_BV	Location:	W
ADA ID: B6D5506279E6	Ramp Type: BlendTrans1	Initial Pass/Fail: Fail	Overall Compliance: No	Severity Score: 1.25
Codes/Mitigation Info/Possible Solution		Field Measurements/Component Compliance

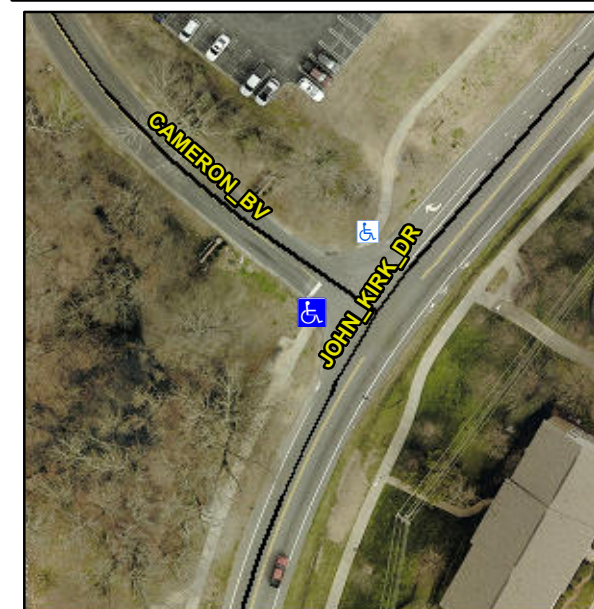
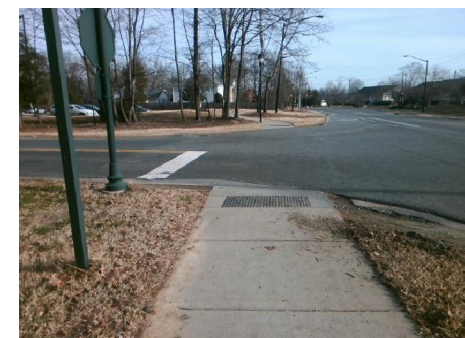
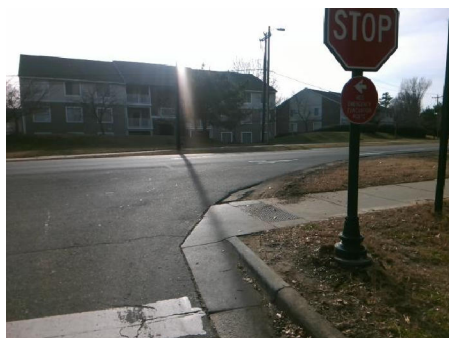
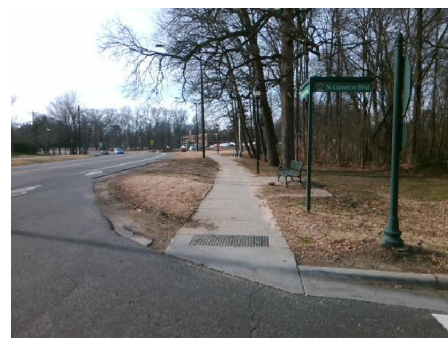
NO CURB

R304.5.3

Compliance	Description	Data	Compliance	Description	Data
N/A	Ramp Length (in)	38.0	Yes	BlendTrans Slope (%)	2.6
Yes	Ramp Width (in)	70.0	No	BlendTrans XSlope (%)	2.1
N/A	Flare Type LT	N/A	N/A	Flare Type RT	N/A
N/A	Flare Slope LT (%)	N/A	N/A	Flare Slope RT (%)	N/A
N/A	Flare Traversable LT?	N/A	N/A	Flare Traversable RT?	N/A
N/A	Landing Length (in)	N/A	N/A	DWS Provided?	N/A
N/A	Landing Width (in)	N/A	N/A	DWS Contrast?	N/A
N/A	Landing Slope (%)	N/A	N/A	DWS Length (in)	N/A
N/A	Landing X Slope (%)	N/A	N/A	DWS Full Width?	N/A
N/A	Landing Curb? (Y/N)	N/A	N/A	DWS Offset (in)	N/A
N/A	Shared Landing?	N/A			
N/A	Gutter Ponding?	N/A	N/A	Gutter Slope (%)	N/A
N/A	Gutter Lip Ht (in)	N/A	N/A	Gutter X Slope (%)	N/A
N/A	Painted X Walk1?	No	N/A	Painted X Walk2?	N/A
	X Walk 1 Direction	To NE		X Walk 2 Direction	N/A
	X Walk 1 Width (in)	N/A		X Walk 2 Width (in)	N/A
	X Walk 1 Slope (%)	0.4		X Walk 2 Slope (%)	N/A
	X Walk 1 X Slope (%)	6.9		X Walk 2 X Slope (%)	N/A

N/A	Ramp inside XWalk1?	N/A	N/A	Ramp inside XWalk2?	N/A
	Road Slope (%)	6.9		Clear Space?	N/A
	Road X Slope (%)	0.4	N/A	Clear Space to XWalk (in)	N/A
N/A	Any Obstructions?	N/A	N/A	Storm Grate/Utility Hazard?	N/A
	Obstruction Type			Storm Grate/Utility Type	
		N/A			N/A
			Yes	Surface Condition? (G/P)	Good
			N/A	Curb Slope (%)	0.1

Remove & Replace Curb Ramp With Two New Directional Ramps or Equivalent.
