Access Compliance Report

Public Rights-of-Way

(Curb Ramps)

Intersection ID: 10039626	Main Street: THORNTON_RD	Cross Street: N/A	Location: NW
ADA ID: B6DFAC27FB6F	Ramp Type: Perp	Initial Pass/Fail: Pass	Overall Compliance: No
		Severity Score: 0

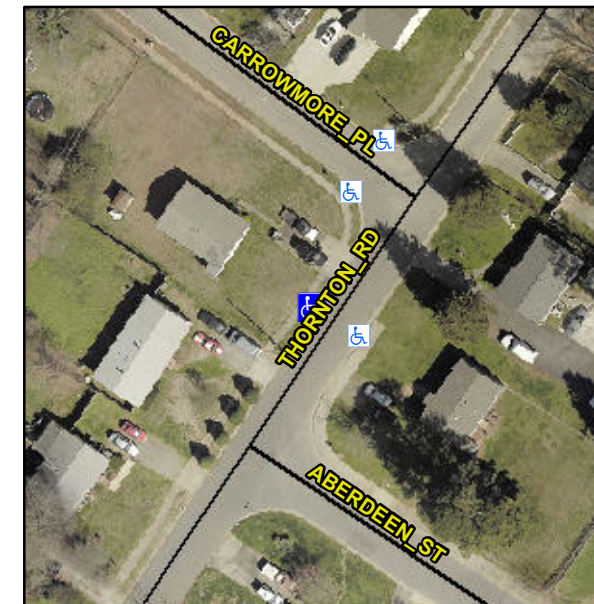
Compliance	Description	Data	Compliance	Description	Data
N/A	Ramp Length (in)	47.5	Yes	Ramp Slope (%)	7.4
Yes	Ramp Width (in)	48.0	Yes	Ramp XSlope (%)	0.4
N/A	Flare Type LT	Sloped	N/A	Flare Type RT	N/A
N/A	Flare Slope LT (%)	6.6	Yes	Flare Slope RT (%)	4.6
N/A	Flare Traversable LT?	Yes	N/A	Flare Traversable RT?	Yes
Yes	Landing Length (in)	58.5	Yes	DWS Provided?	Yes
Yes	Landing Width (in)	48.0	Yes	DWS Contrast?	Yes
Yes	Landing Slope (%)	1.6	Yes	DWS Length (in)	24.0
Yes	Landing X Slope (%)	1.1	Yes	DWS Full Width?	Yes
N/A	Landing Curb? (Y/N)	No	Yes	DWS Offset (in)	0.0
N/A	Shared Landing?	No			
Yes	Gutter Ponding?	No	Yes	Gutter Slope (%)	0.1
Yes	Gutter Lip Ht (in)	0.0	Yes	Gutter X Slope (%)	0.4
N/A	Painted X Walk1?	No	N/A	Painted X Walk2?	N/A
	X Walk 1 Direction	To SE		X Walk 2 Direction	N/A
N/A	X Walk 1 Width (in)	N/A	N/A	X Walk 2 Width (in)	N/A
	X Walk 1 Slope (%)	3.0		X Walk 2 Slope (%)	N/A
	X Walk 1 X Slope (%)	0.7		X Walk 2 X Slope (%)	N/A

N/A	Ramp inside XWalk1?	N/A	N/A	Ramp inside XWalk2?	N/A
	Road Slope (%)	N/A	N/A	Clear Space?	Yes
	Road X Slope (%)	N/A	N/A	Clear Space to XWalk (in)	N/A
Yes	Any Obstructions?	No	Yes	Storm Grate/Utility Hazard?	No
	Obstruction Type			Storm Grate/Utility Type	
		N/A			N/A
			Yes	Surface Condition? (G/P)	Good

Possible Solutions:

Remove & Replace Entire Ramp.
