## Access Compliance Report Public Rights-of-Way (Curb Ramps)

Intersection ID: 27432 Main Street: BALLANTYNE\_COMMONS\_PY Cross Street: DURANT\_BV Location: SE

ADA ID: B6F7024C9E4F Ramp Type: Perp Initial Pass/Fail: Fail Overall Compliance: No Severity Score: 22.5

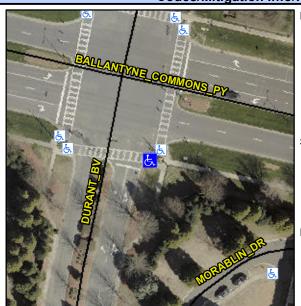
Field Measurements/Component Compliance						
Comp	liance Description	Data	Comp	liance Description	Data	
N/A	Ramp Length (in)	198.0	Yes	Ramp Slope (%)	11.5	
No	Ramp Width (in)	42.5	Yes	Ramp XSlope (%)	2.3	
N/A	Flare Type LT	N/A	N/A	Flare Type RT	N/A	
N/A	Flare Slope LT (%)	N/A	N/A	Flare Slope RT (%)	N/A	
N/A	Flare Traversable LT?	N/A	N/A	Flare Traversable RT?	N/A	
N/A	Landing Length (in)	N/A	N/A	DWS Provided?	N/A	
N/A	Landing Width (in)	N/A	N/A	DWS Contrast?	N/A	
N/A	Landing Slope (%)	N/A	N/A	DWS Length (in)	N/A	
N/A	Landing X Slope (%)	N/A	N/A	DWS Full Width?	N/A	
N/A	Landing Curb? (Y/N)	N/A	N/A	DWS Offset (in)	N/A	
N/A	Shared Landing?	N/A				
N/A	Gutter Ponding?	N/A	N/A	Gutter Slope (%)	N/A	
N/A	Gutter Lip Ht (in)	N/A	N/A	Gutter X Slope (%)	N/A	
N/A	Painted X Walk1?	Yes	N/A	Painted X Walk2?	N/A	
	X Walk 1 Direction	To W		X Walk 2 Direction	N/A	
N/A	X Walk 1 Width (in)	126.0	N/A	X Walk 2 Width (in)	N/A	
	X Walk 1 Slope (%)	4.9		X Walk 2 Slope (%)	N/A

X Walk 1 X Slope (%)	2.8		X Walk 2 X Slope (%)	N/A	
N/A	Ramp inside XWalk1?	Yes	N/A	Ramp inside XWalk2?	N/A	
	Road Slope (%)	N/A	N/A	Clear Space?	N/A	
	Road X Slope (%)	N/A	N/A	Clear Space to XWalk (in)	N/A	
N/A	Any Obstructions?	N/A	N/A	Storm Grate/Utility Hazard?	N/A	
	Obstruction Type			Storm Grate/Utility Type		
		N/A			N/A	
			Yes	Surface Condition? (G/P)	Good	
-13	A AA.

Possible Solution	
Possible Solutions:	Com
Remove & Replace Entire Ramp.	N/A
	No
	N/A
	N/A
	N/A
	N/A
Surveyor Notes:	N/A
N/A	N/A
	N/A
	N/A
	N/A
PROW/ADA:	N/A
Not Found, R304.5.1	N/A
	N/A
	N/A
	N/A

Total Cost:	\$ 1850.00
