Access Compliance Report

Public Rights-of-Way

(Curb Ramps)

Intersection ID: N/A	Main Street: GLENBURN_LN	Cross Street: KINGAUSSIE	Location: NE
ADA ID: B709E4201C17	Ramp Type: PerpDiag	Initial Pass/Fail: Fail	Overall Compliance: No
		Severity Score: 8.75

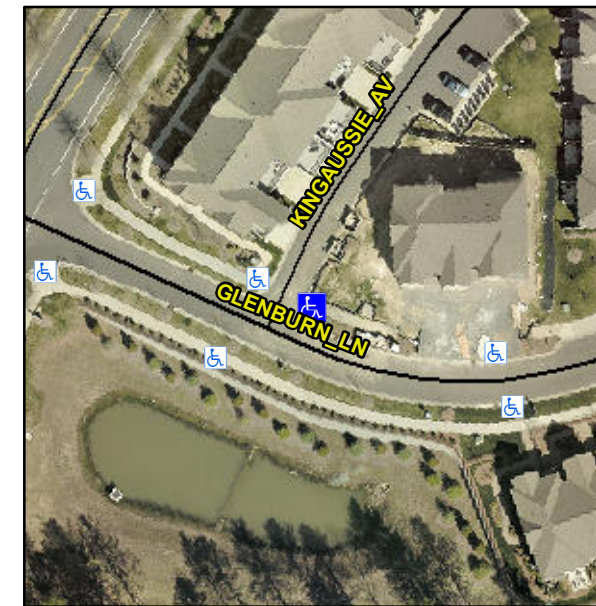
Compliance	Description	Data	Compliance	Description	Data
N/A	Ramp Length (in)	104.0	Yes	Ramp Slope (%)	7.9
No	Ramp Width (in)	43.0	Yes	Ramp XSlope (%)	1.2
N/A	Flare Type LT	N/A	N/A	Flare Type RT	N/A
N/A	Flare Slope LT (%)	N/A	N/A	Flare Slope RT (%)	N/A
N/A	Flare Traversable LT?	N/A	N/A	Flare Traversable RT?	N/A
N/A	Landing Length (in)	N/A	N/A	DWS Provided?	N/A
N/A	Landing Width (in)	N/A	N/A	DWS Contrast?	N/A
N/A	Landing Slope (%)	N/A	N/A	DWS Length (in)	N/A
N/A	Landing X Slope (%)	N/A	N/A	DWS Full Width?	N/A
N/A	Landing Curb? (Y/N)	N/A	N/A	DWS Offset (in)	N/A
N/A	Shared Landing?	N/A			
N/A	Gutter Ponding?	N/A	N/A	Gutter Slope (%)	N/A
N/A	Gutter Lip Ht (in)	N/A	N/A	Gutter X Slope (%)	N/A
N/A	Painted X Walk1?	No	N/A	Painted X Walk2?	No
	X Walk 1 Direction	To NW		X Walk 2 Direction	To SW
N/A	X Walk 1 Width (in)	N/A	N/A	X Walk 2 Width (in)	N/A
	X Walk 1 Slope (%)	0.8		X Walk 2 Slope (%)	2.1
	X Walk 1 X Slope (%)	2.0		X Walk 2 X Slope (%)	0.9

N/A	Ramp inside XWalk1?	N/A	N/A	Ramp inside XWalk2?	N/A
	Road Slope (%)	1.2	N/A	Clear Space?	N/A
	Road X Slope (%)	1.3	N/A	Clear Space to XWalk (in)	N/A
N/A	Any Obstructions?	N/A	N/A	Storm Grate/Utility Hazard?	N/A
	Obstruction Type			Storm Grate/Utility Type	
		N/A			N/A
			Yes	Surface Condition? (G/P)	Good

Remove & Replace Curb Ramp With Two New Directional Ramps or Equivalent.

Not Found, R304.5.1

Total Cost: \$ 3200.00
