Access Compliance Report

Public Rights-of-Way

(Curb Ramps)

Intersection ID: 11232	Main Street: BARRINGTON_DR	Cross Street: MILTON_RD	Location: NE
ADA ID: B71181D9D7EE	Ramp Type: PerpDiag	Initial Pass/Fail: Fail	Overall Compliance: No
Codes/Mitigation Info/Possible Solution		Field Measurements/Component Compliance	
Severity Score: 21.25

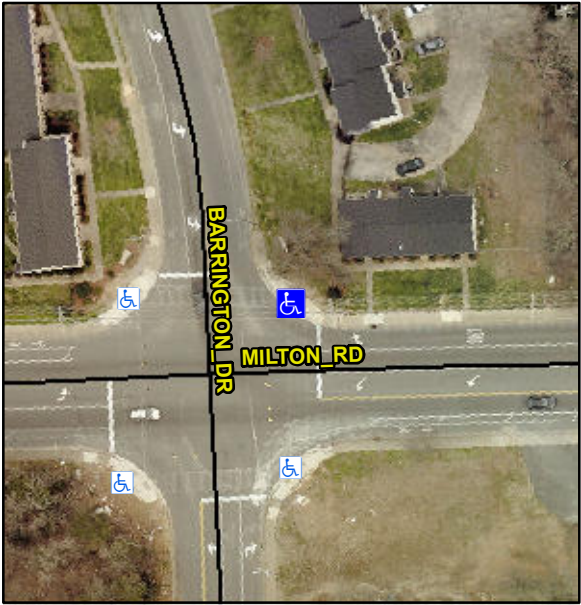
Possible Solutions:		Compliance	Description	Data	Compliance	Description	Data
	Remove & Replace Curb Ramp With Two New Directional Ramps or Equivalent.		N/A	Ramp Length (in)	60.0	No	Ramp Slope (%)	11.5
<p>Surveyor Notes:</p> <p>N/A</p> <p>PROW/ADA:</p> <p>Not Found, R304.5.1, R304.2.2</p>			No	Ramp Width (in)	41.5	Yes	Ramp XSlope (%)	0.5
			N/A	Flare Type LT	N/A	N/A	Flare Type RT	N/A
			N/A	Flare Slope LT (%)	N/A	N/A	Flare Slope RT (%)	N/A
			N/A	Flare Traversable LT?	N/A	N/A	Flare Traversable RT?	N/A
			N/A	Landing Length (in)	N/A	N/A	DWS Provided?	N/A
			N/A	Landing Width (in)	N/A	N/A	DWS Contrast?	N/A
			N/A	Landing Slope (%)	N/A	N/A	DWS Length (in)	N/A
			N/A	Landing X Slope (%)	N/A	N/A	DWS Full Width?	N/A
			N/A	Landing Curb? (Y/N)	N/A	N/A	DWS Offset (in)	N/A
			N/A	Shared Landing?	N/A			
			N/A	Gutter Ponding?	N/A	N/A	Gutter Slope (%)	N/A
			N/A	Gutter Lip Ht (in)	N/A	N/A	Gutter X Slope (%)	N/A

N/A	Painted X Walk1?	No	N/A	Painted X Walk2?	No
				X Walk 1 Direction	To W		X Walk 2 Direction	To S
			N/A	X Walk 1 Width (in)	N/A	N/A	X Walk 2 Width (in)	N/A
				X Walk 1 Slope (%)	0.4		X Walk 2 Slope (%)	2.8
				X Walk 1 X Slope (%)	0.4		X Walk 2 X Slope (%)	0.8
			N/A	Ramp inside XWalk1?	N/A	N/A	Ramp inside XWalk2?	N/A
				Road Slope (%)	1.0	N/A	Clear Space?	N/A
				Road X Slope (%)	2.6	N/A	Clear Space to XWalk (in)	N/A
			N/A	Any Obstructions?	N/A	N/A	Storm Grate/Utility Hazard?	N/A
				Obstruction Type			Storm Grate/Utility Type	
						N/A		N/A
						Yes	Surface Condition? (G/P)	Good
