# Access Compliance Report

## Public Rights-of-Way

### (Curb Ramps)

Intersection ID: 17577	Main Street: HARRIS_RD	Cross Street: PROVIDENCE_RD	Location: SW
ADA ID: B7171DE4F980	Ramp Type: PerpDiag	Initial Pass/Fail: Fail	Overall Compliance: No
			Severity Score: 33.75

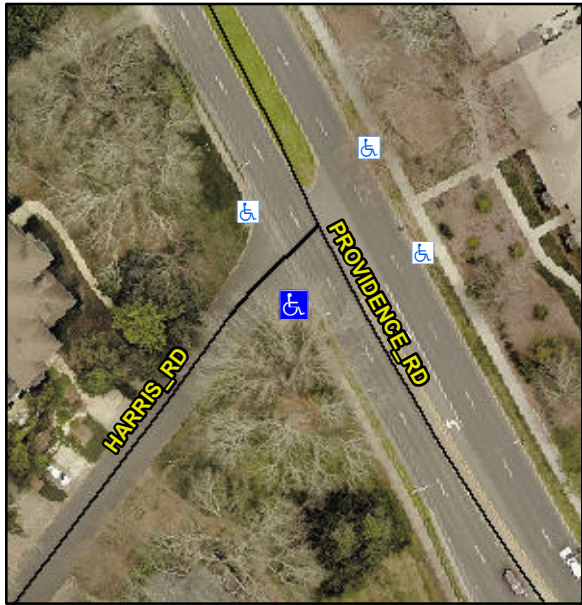
Possible Solutions:		Compliance	Description	Data	Compliance	Description	Data
	<b>Remove &amp; Replace Curb Ramp With Two New Directional Ramps or Equivalent.</b>		N/A	Ramp Length (in)	38.0	No	Ramp Slope (%)	9.7
			No	Ramp Width (in)	43.0	No	Ramp XSlope (%)	5.3
			N/A	Flare Type LT	N/A	N/A	Flare Type RT	N/A
			N/A	Flare Slope LT (%)	N/A	N/A	Flare Slope RT (%)	N/A
			N/A	Flare Traversable LT?	N/A	N/A	Flare Traversable RT?	N/A
			N/A	Landing Length (in)	N/A	N/A	DWS Provided?	N/A
			N/A	Landing Width (in)	N/A	N/A	DWS Contrast?	N/A
			N/A	Landing Slope (%)	N/A	N/A	DWS Length (in)	N/A
			N/A	Landing X Slope (%)	N/A	N/A	DWS Full Width?	N/A
Surveyor Notes:		N/A	N/A	Landing Curb? (Y/N)	N/A	N/A	DWS Offset (in)	N/A
PROW/ADA:		Not Found, R304.5.1, R304.2.2, R304.5.3	N/A	Shared Landing?	N/A	N/A	Gutter Slope (%)	N/A
			N/A	Gutter Ponding?	N/A	N/A	Gutter X Slope (%)	N/A

N/A	Gutter Lip Ht (in)	N/A	N/A	Painted X Walk2?	No
				Painted X Walk1?	No	N/A	X Walk 2 Direction	To NW
				X Walk 1 Direction	To E		X Walk 2 Width (in)	N/A
			N/A	X Walk 1 Width (in)	N/A	N/A	X Walk 2 Slope (%)	4.2
				X Walk 1 Slope (%)	0.6		X Walk 2 X Slope (%)	7.3
				X Walk 1 X Slope (%)	3.1		Ramp inside XWalk2?	N/A
			N/A	Ramp inside XWalk1?	N/A	N/A	Clear Space?	N/A
				Road Slope (%)	3.1	N/A	Clear Space to XWalk (in)	N/A
				Road X Slope (%)	1.7	N/A	Storm Grate/Utility Hazard?	N/A
			N/A	Any Obstructions?	N/A	N/A	Storm Grate/Utility Type	
				Obstruction Type				
						N/A		N/A
						Yes	Surface Condition? (G/P)	Good
