# Access Compliance Report

## Public Rights-of-Way

### (Curb Ramps)

Intersection ID: 10020376	Main Street: BALLANTYNE_CORPORATE_PC	Cross Street: N/A	Location: SW
ADA ID: B71E570A28D8	Ramp Type: Perp	Initial Pass/Fail: Fail	Overall Compliance: No
Severity Score: 10			
Codes/Mitigation Info/Possible Solution		Field Measurements/Component Compliance

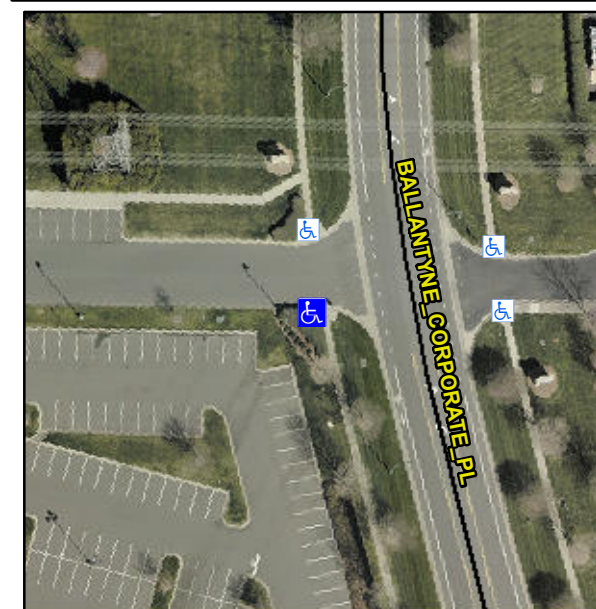
**Not Found, R304.5.1, R304.5.3**

Compliance	Description	Data	Compliance	Description	Data
N/A	Ramp Length (in)	58.0	Yes	Ramp Slope (%)	6.5
No	Ramp Width (in)	42.0	No	Ramp XSlope (%)	2.4
N/A	Flare Type LT	N/A	N/A	Flare Type RT	N/A
N/A	Flare Slope LT (%)	N/A	N/A	Flare Slope RT (%)	N/A
N/A	Flare Traversable LT?	N/A	N/A	Flare Traversable RT?	N/A
N/A	Landing Length (in)	N/A	N/A	DWS Provided?	N/A
N/A	Landing Width (in)	N/A	N/A	DWS Contrast?	N/A
N/A	Landing Slope (%)	N/A	N/A	DWS Length (in)	N/A
N/A	Landing X Slope (%)	N/A	N/A	DWS Full Width?	N/A
N/A	Landing Curb? (Y/N)	N/A	N/A	DWS Offset (in)	N/A
N/A	Shared Landing?	N/A			
N/A	Gutter Ponding?	N/A	N/A	Gutter Slope (%)	N/A
N/A	Gutter Lip Ht (in)	N/A	N/A	Gutter X Slope (%)	N/A
N/A	Painted X Walk1?	No	N/A	Painted X Walk2?	N/A
	X Walk 1 Direction	To N		X Walk 2 Direction	N/A
N/A	X Walk 1 Width (in)	N/A	N/A	X Walk 2 Width (in)	N/A
	X Walk 1 Slope (%)	3.9		X Walk 2 Slope (%)	N/A
	X Walk 1 X Slope (%)	1.0		X Walk 2 X Slope (%)	N/A

N/A	Ramp inside XWalk1?	N/A	N/A	Ramp inside XWalk2?	N/A
	Road Slope (%)	N/A	N/A	Clear Space?	N/A
	Road X Slope (%)	N/A	N/A	Clear Space to XWalk (in)	N/A
N/A	Any Obstructions?	N/A	N/A	Storm Grate/Utility Hazard?	N/A
	Obstruction Type			Storm Grate/Utility Type	
		N/A			N/A
			Yes	Surface Condition? (G/P)	Good

**Remove & Replace Entire Ramp.**
