Access Compliance Report

Public Rights-of-Way (Curb Ramps)

Intersection ID: 22686	Main Street: INDIAN_HILLS_LN	Cross Street: MAPLE_SPRING_DR	Location:	S
ADA ID: B71F6F24AC13	Ramp Type: Directional1	Initial Pass/Fail: Fail	Overall Compliance: No	Severity Score: 8.75
Codes/Mitigation Info/Possible Solution		Field Measurements/Component Compliance

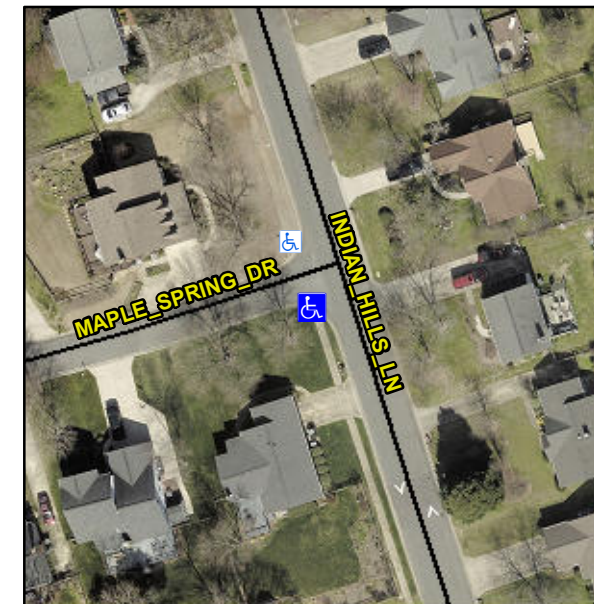
Compliance	Description	Data	Compliance	Description	Data
N/A	Ramp Length (in)	54.0	N/A	Grade Break?	N/A
No	Ramp Width (in)	36.0	N/A	Grade Break Slope (%)	0.0
Yes	Ramp Slope (%)	5.6	N/A	Grade Break XSlope (%)	0.0
Yes	Ramp XSlope (%)	1.7			
N/A	Flare Type LT	N/A	N/A	Flare Type RT	N/A
N/A	Flare Slope LT (%)	N/A	N/A	Flare Slope RT (%)	0.0
N/A	Flare Traversable LT?	N/A	N/A	Flare Traversable RT?	N/A
N/A	Landing Length (in)	0.0	N/A	DWS Provided?	N/A
N/A	Landing Width (in)	0.0	N/A	DWS Contrast?	N/A
N/A	Landing Slope (%)	0.0	N/A	DWS Length (in)	N/A
N/A	Landing X Slope (%)	0.0	N/A	DWS Full Width?	N/A
N/A	Landing Curb? (Y/N)	N/A	N/A	DWS Offset LT (in)	N/A
N/A	Shared Landing?	N/A	N/A	DWS Offset RT (in)	N/A
N/A	Gutter Ponding?	0.0	N/A	Gutter Slope (%)	N/A
N/A	Gutter Lip Ht (in)	0.0	N/A	Gutter X Slope (%)	N/A
N/A	Painted X Walk1?	No		Road Slope (%)	2.5
	X Walk 1 Direction	To NW		Road X Slope (%)	2.8
	X Walk 1 Width (in)	N/A		Clear Space?	N/A

X Walk 1 Slope (%)	2.5	N/A	Clear Space to XWalk (in)	N/A
	X Walk 1 X Slope (%)	2.8	N/A	Storm Grate/Utility Hazard?	N/A
N/A	Ramp inside XWalk1?	N/A		Storm Grate/Utility Type	
N/A	Any Obstructions?	N/A			N/A
	Obstruction Type		Yes	Surface Condition? (G/P)	Good
			N/A	Curb Slope (%)	11.8

Remove & Replace Entire Ramp.

R304.5.1
