Access Compliance Report Public Rights-of-Way (Curb Ramps)

Intersection ID: 3583 Main Street: ARDEN_GATE_LN Cross Street: TREYMORE_LN Location: S

ADA ID: B7286A8A78AA Ramp Type: Perp Initial Pass/Fail: Fail Overall Compliance: No Severity Score: 12.5

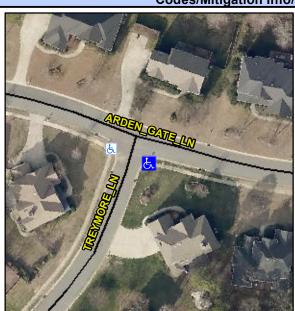
Compliance Description <u>Data</u> Compliance Description Data Ramp Length (in) Yes N/A 47.0 Ramp Slope (%) 7.3 No Ramp XSlope (%) Yes Ramp Width (in) 48.0 6.9 N/A Flare Type LT N/A N/A Flare Type RT N/A N/A N/A Flare Slope RT (%) Flare Slope LT (%) N/A N/A N/A Flare Traversable LT? N/A N/A Flare Traversable RT? N/A N/A N/A N/A **DWS Provided?** N/A Landing Length (in) N/A Landing Width (in) N/A N/A **DWS Contrast?** N/A N/A N/A Landing Slope (%) N/A DWS Length (in) N/A N/A Landing X Slope (%) N/A N/A DWS Full Width? N/A N/A Landing Curb? (Y/N) N/A N/A DWS Offset (in) N/A N/A N/A Shared Landing? N/A **Gutter Ponding?** N/A N/A Gutter Slope (%) N/A N/A Gutter Lip Ht (in) N/A N/A Gutter X Slope (%) N/A N/A Painted X Walk1? No N/A Painted X Walk2? N/A X Walk 1 Direction To NW X Walk 2 Direction N/A N/A N/A X Walk 1 Width (in) X Walk 2 Width (in) N/A X Walk 1 Slope (%) 3.9 X Walk 2 Slope (%) N/A X Walk 1 X Slope (%) 2.6 X Walk 2 X Slope (%) N/A N/A N/A N/A Ramp inside XWalk1? Ramp inside XWalk2? N/A Road Slope (%) N/A N/A Clear Space? N/A Road X Slope (%) N/A N/A Clear Space to XWalk (in) N/A N/A N/A Any Obstructions? N/A Storm Grate/Utility Hazard? N/A **Obstruction Type** Storm Grate/Utility Type N/A N/A

Remove & Replace Entire Ramp.

Not Found, R304.5.3
