# Access Compliance Report

## Public Rights-of-Way

### (Curb Ramps)

Intersection ID: 6194	Main Street: LIATRIS_LN	Cross Street: VALERIAN_CT	Location: W
ADA ID: B72A7357BE86	Ramp Type: Perp	Initial Pass/Fail: Fail	Overall Compliance: No
Severity Score: 46.25			
Codes/Mitigation Info/Possible Solution		Field Measurements/Component Compliance

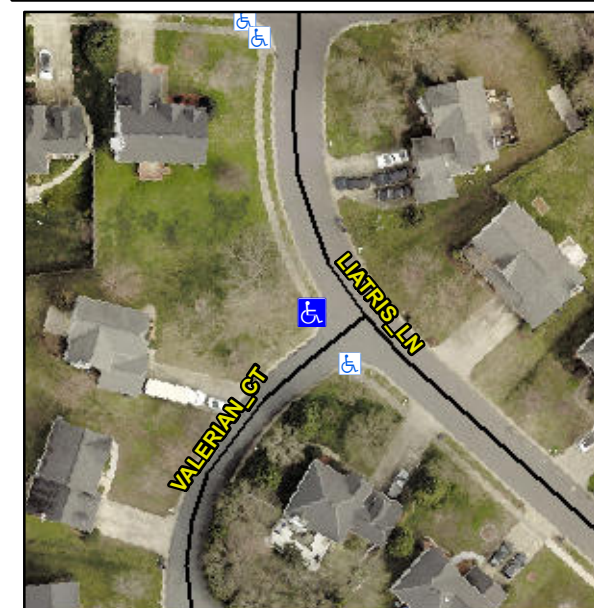
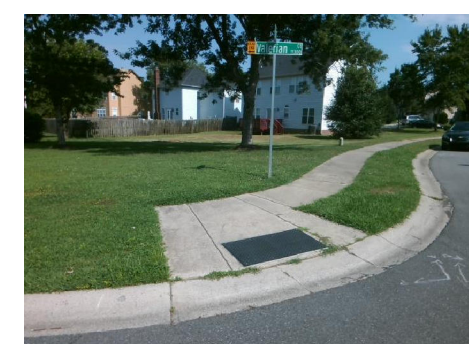
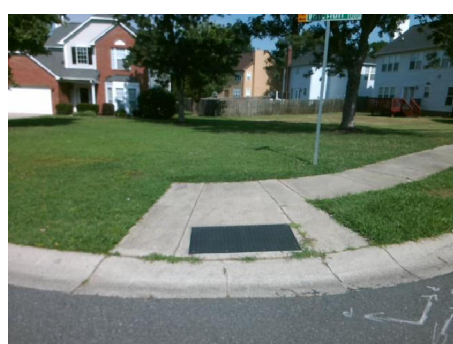
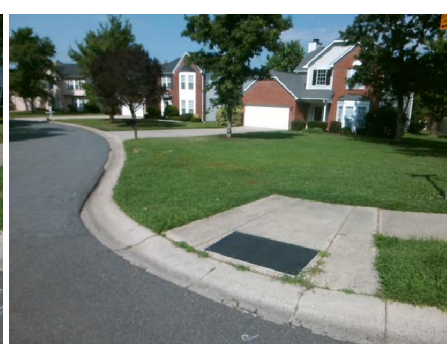
**Not Found, R304.5.1, R304.2.2, R304.5.3**

Compliance	Description	Data	Compliance	Description	Data
N/A	Ramp Length (in)	49.0	No	Ramp Slope (%)	12.1
No	Ramp Width (in)	46.0	No	Ramp XSlope (%)	5.6
N/A	Flare Type LT	N/A	N/A	Flare Type RT	N/A
N/A	Flare Slope LT (%)	N/A	N/A	Flare Slope RT (%)	N/A
N/A	Flare Traversable LT?	N/A	N/A	Flare Traversable RT?	N/A
N/A	Landing Length (in)	N/A	N/A	DWS Provided?	N/A
N/A	Landing Width (in)	N/A	N/A	DWS Contrast?	N/A
N/A	Landing Slope (%)	N/A	N/A	DWS Length (in)	N/A
N/A	Landing X Slope (%)	N/A	N/A	DWS Full Width?	N/A
N/A	Landing Curb? (Y/N)	N/A	N/A	DWS Offset (in)	N/A
N/A	Shared Landing?	N/A			
N/A	Gutter Ponding?	N/A	N/A	Gutter Slope (%)	N/A
N/A	Gutter Lip Ht (in)	N/A	N/A	Gutter X Slope (%)	N/A
N/A	Painted X Walk1?	No	N/A	Painted X Walk2?	N/A
	X Walk 1 Direction	To SE		X Walk 2 Direction	N/A
N/A	X Walk 1 Width (in)	N/A	N/A	X Walk 2 Width (in)	N/A
	X Walk 1 Slope (%)	2.7		X Walk 2 Slope (%)	N/A
	X Walk 1 X Slope (%)	4.3		X Walk 2 X Slope (%)	N/A

N/A	Ramp inside XWalk1?	N/A	N/A	Ramp inside XWalk2?	N/A
	Road Slope (%)	N/A	N/A	Clear Space?	N/A
	Road X Slope (%)	N/A	N/A	Clear Space to XWalk (in)	N/A
N/A	Any Obstructions?	N/A	N/A	Storm Grate/Utility Hazard?	N/A
	Obstruction Type			Storm Grate/Utility Type	
		N/A			N/A
			Yes	Surface Condition? (G/P)	Good

**Remove & Replace Entire Ramp.**
