Access Compliance Report Public Rights-of-Way (Curb Ramps)

Main Street: SELDON DR **Cross Street: W TRADE ST** Location: Intersection ID: 10096 Ramp Type: PerpDiag Initial Pass/Fail: Fail **Overall Compliance: No** Severity Score: 21.25 **ADA ID: B72ADB25A747**

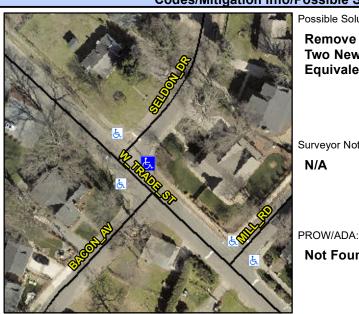
Not Found, R304.5.1, R304.2.2

Com	pliance Description	Data	Comp	oliance Description	
N/A	Ramp Length (in)	74.0	No	Ramp Slope (%)	
No	Ramp Width (in)	47.5	Yes	Ramp XSlope (%)	
N/A	Flare Type LT	N/A	N/A	Flare Type RT	
N/A	Flare Slope LT (%)	N/A	N/A	Flare Slope RT (%)	
N/A	Flare Traversable LT?	N/A	N/A	Flare Traversable RT?	
N/A	Landing Length (in)	N/A	N/A	DWS Provided?	
N/A	Landing Width (in)	N/A	N/A	DWS Contrast?	
N/A	Landing Slope (%)	N/A	N/A	DWS Length (in)	
N/A	Landing X Slope (%)	N/A	N/A	DWS Full Width?	
N/A	Landing Curb? (Y/N)	N/A	N/A	DWS Offset (in)	
N/A	Shared Landing?	N/A			
N/A	Gutter Ponding?	N/A	N/A	Gutter Slope (%)	
N/A	Gutter Lip Ht (in)	N/A	N/A	Gutter X Slope (%)	
N/A	Painted X Walk1?	No	N/A	Painted X Walk2?	
	X Walk 1 Direction	To NW		X Walk 2 Direction	
N/A	X Walk 1 Width (in)	N/A	N/A	X Walk 2 Width (in)	
	X Walk 1 Slope (%)	2.8		X Walk 2 Slope (%)	
	X Walk 1 X Slope (%)	0.4		X Walk 2 X Slope (%)	
N/A	Ramp inside XWalk1?	N/A	N/A	Ramp inside XWalk2?

Possible Solutions: Remove & Replace Curb Ramp With Two New Directional Ramps or Equivalent. Surveyor Notes: N/A
