## Access Compliance Report Public Rights-of-Way (Curb Ramps)

Intersection ID: 15436 Main Street: LAWNDALE\_RD Cross Street: POINDEXTER\_DR Location: W

ADA ID: B72CC6DA3671 Ramp Type: PerpDiag Initial Pass/Fail: Fail Overall Compliance: No Severity Score: 40

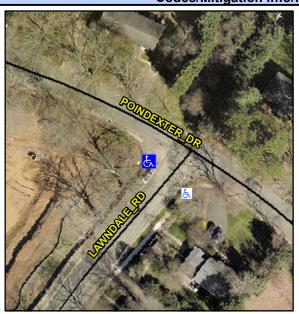
Not Found, R304.2.2, R302.7

Compliance Description Data Compliance Description Data No N/A Ramp Length (in) 51.0 Ramp Slope (%) 14.7 Yes Ramp XSlope (%) Yes Ramp Width (in) 48.0 8.0 N/A N/A Flare Type LT N/A Flare Type RT N/A N/A N/A N/A Flare Slope RT (%) N/A Flare Slope LT (%) N/A Flare Traversable LT? N/A N/A Flare Traversable RT? N/A N/A N/A N/A **DWS Provided?** N/A Landing Length (in) N/A Landing Width (in) N/A N/A **DWS Contrast?** N/A N/A N/A N/A Landing Slope (%) DWS Length (in) N/A N/A Landing X Slope (%) N/A N/A DWS Full Width? N/A N/A Landing Curb? (Y/N) N/A N/A DWS Offset (in) N/A N/A N/A Shared Landing? N/A Gutter Ponding? N/A N/A Gutter Slope (%) N/A N/A Gutter Lip Ht (in) N/A N/A Gutter X Slope (%) N/A N/A Painted X Walk1? No N/A Painted X Walk2? No X Walk 1 Direction To SE X Walk 2 Direction To NE N/A N/A X Walk 1 Width (in) X Walk 2 Width (in) N/A X Walk 1 Slope (%) 6.0 X Walk 2 Slope (%) 3.6 X Walk 2 X Slope (%) X Walk 1 X Slope (%) 0.5 4.0 N/A N/A N/A Ramp inside XWalk2? N/A Ramp inside XWalk1? Road Slope (%) 2.3 N/A Clear Space? N/A N/A Road X Slope (%) 4.5 Clear Space to XWalk (in) N/A N/A N/A N/A Any Obstructions? Storm Grate/Utility Hazard? N/A **Obstruction Type** Storm Grate/Utility Type N/A N/A

Poor

Remove & Replace Curb Ramp With Two New Directional Ramps or Equivalent.
