# Access Compliance Report

## Public Rights-of-Way

### (Curb Ramps)

| Intersection ID: 26934 | Main Street: HADDONSHIRE_LN | Cross Street: LADY_GRACE_LN | Location: NE |

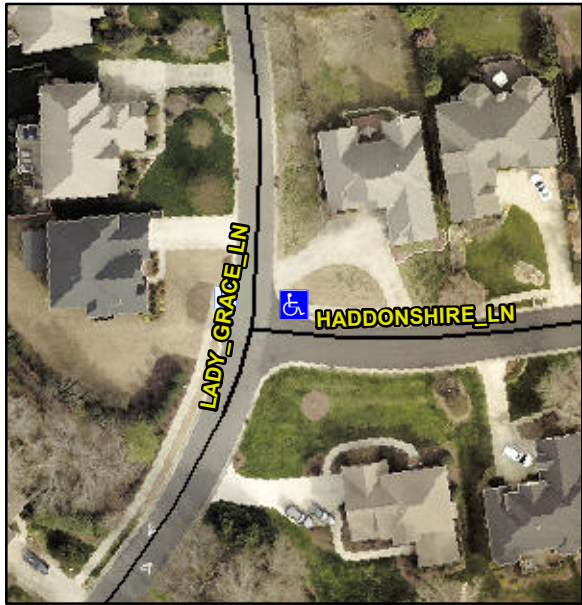
| ADA ID: B72F44A1DBF4 | Ramp Type: Perp | Initial Pass/Fail: Fail | Overall Compliance: No |

| Codes/Mitigation Info/Possible Solution | | | Field Measurements/Component Compliance | | | | | |
|---|---|--|---|---|---|---|---|---|
| | PROW/ADA: | | <b>Not Found, R304.2.2, R304.5.3</b> | | | | | |
| | | | <b>N/A</b> | Ramp Length (in) | <b>73.0</b> | <b>No</b> | Ramp Slope (%) | <b>10.2</b> |
| | | | <b>Yes</b> | Ramp Width (in) | <b>48.0</b> | <b>No</b> | Ramp XSlope (%) | <b>4.1</b> |

| Codes/Mitigation Info/Possible Solution | | | Field Measurements/Component Compliance | | | | | |
|---|---|--|---|---|---|---|---|---|
| | Possible Solutions: | | <b>Remove &amp; Replace Entire Ramp.</b> | | | | | |
| | Total Cost: | | <b>\$ 1850.00</b> | | | | | |
