Access Compliance Report

Public Rights-of-Way

(Curb Ramps)

Intersection ID: 11639	Main Street: PARKWOOD_AV	Cross Street: PEGRAM_ST	Location: NW
ADA ID: B738D007792D	Ramp Type: Perp	Initial Pass/Fail: Fail	Overall Compliance: No
Codes/Mitigation Info/Possible Solution		Field Measurements/Component Compliance

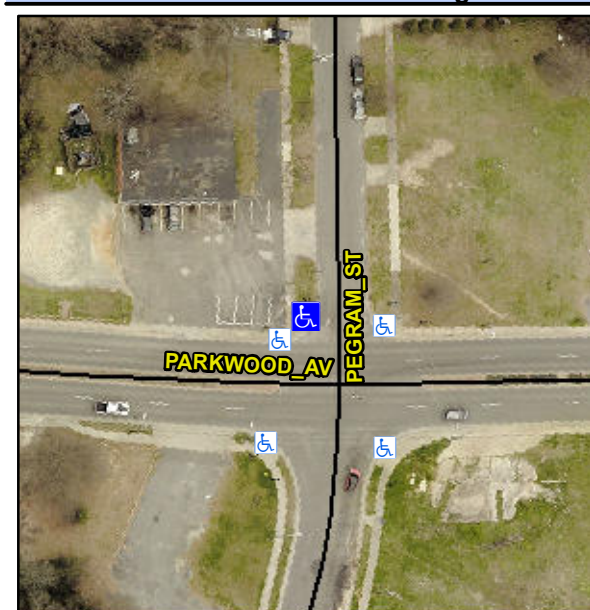
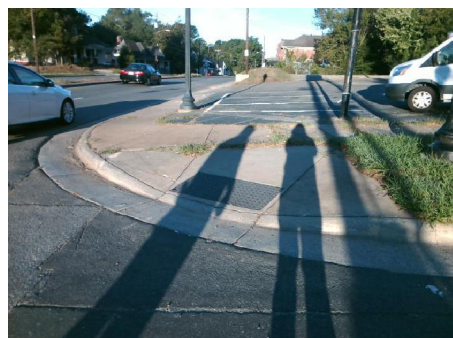
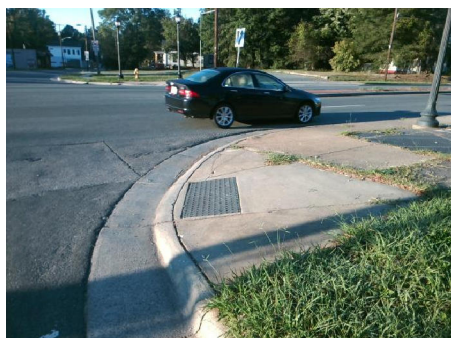
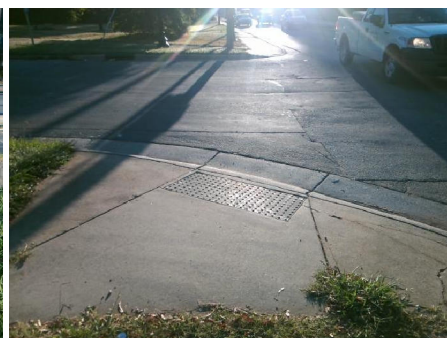
Not Found, R304.2.2, R304.5.3

Compliance	Description	Data	Compliance	Description	Data
N/A	Ramp Length (in)	67.5	No	Ramp Slope (%)	15.5
Yes	Ramp Width (in)	50.5	No	Ramp XSlope (%)	3.2
N/A	Flare Type LT	N/A	N/A	Flare Type RT	N/A
N/A	Flare Slope LT (%)	N/A	N/A	Flare Slope RT (%)	N/A
N/A	Flare Traversable LT?	N/A	N/A	Flare Traversable RT?	N/A
N/A	Landing Length (in)	N/A	N/A	DWS Provided?	N/A
N/A	Landing Width (in)	N/A	N/A	DWS Contrast?	N/A
N/A	Landing Slope (%)	N/A	N/A	DWS Length (in)	N/A
N/A	Landing X Slope (%)	N/A	N/A	DWS Full Width?	N/A
N/A	Landing Curb? (Y/N)	N/A	N/A	DWS Offset (in)	N/A
N/A	Shared Landing?	N/A			
N/A	Gutter Ponding?	N/A	N/A	Gutter Slope (%)	N/A
N/A	Gutter Lip Ht (in)	N/A	N/A	Gutter X Slope (%)	N/A
N/A	Painted X Walk1?	No	N/A	Painted X Walk2?	N/A
	X Walk 1 Direction	To E		X Walk 2 Direction	N/A
N/A	X Walk 1 Width (in)	N/A	N/A	X Walk 2 Width (in)	N/A
	X Walk 1 Slope (%)	0.7		X Walk 2 Slope (%)	N/A
	X Walk 1 X Slope (%)	4.9		X Walk 2 X Slope (%)	N/A

N/A	Ramp inside XWalk1?	N/A	N/A	Ramp inside XWalk2?	N/A
	Road Slope (%)	N/A	N/A	Clear Space?	N/A
	Road X Slope (%)	N/A	N/A	Clear Space to XWalk (in)	N/A
N/A	Any Obstructions?	N/A	N/A	Storm Grate/Utility Hazard?	N/A
	Obstruction Type			Storm Grate/Utility Type	
		N/A			N/A
			Yes	Surface Condition? (G/P)	Good

Possible Solutions:

Remove & Replace Entire Ramp.
