# Access Compliance Report

## Public Rights-of-Way

### (Curb Ramps)

Intersection ID: 2813	Main Street: RIDGEFIELD_DR	Cross Street: SWANSTON_DR	Location: NW
ADA ID: B746E304D3FB	Ramp Type: PerpDiag	Initial Pass/Fail: Fail	Overall Compliance: No
Severity Score: 22.5			
Codes/Mitigation Info/Possible Solution		Field Measurements/Component Compliance

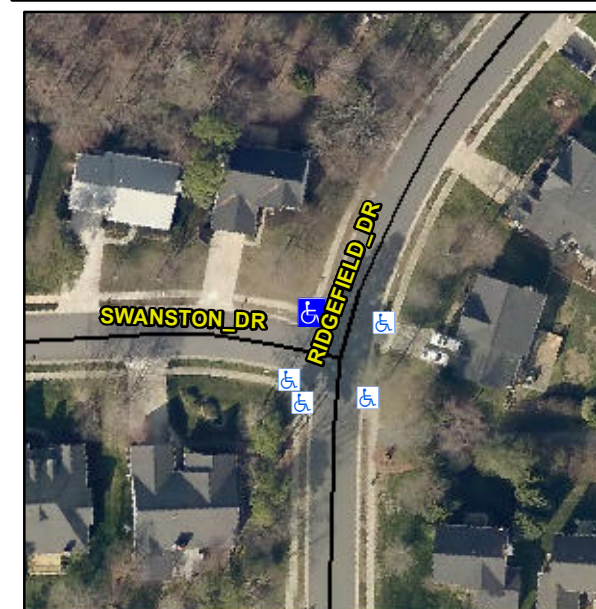
**Not Found, R304.5.1, R304.2.2, R304.5.3**

Compliance	Description	Data	Compliance	Description	Data
N/A	Ramp Length (in)	49.0	No	Ramp Slope (%)	8.7
No	Ramp Width (in)	40.0	No	Ramp XSlope (%)	4.1
N/A	Flare Type LT	N/A	N/A	Flare Type RT	N/A
N/A	Flare Slope LT (%)	N/A	N/A	Flare Slope RT (%)	N/A
N/A	Flare Traversable LT?	N/A	N/A	Flare Traversable RT?	N/A
N/A	Landing Length (in)	N/A	N/A	DWS Provided?	N/A
N/A	Landing Width (in)	N/A	N/A	DWS Contrast?	N/A
N/A	Landing Slope (%)	N/A	N/A	DWS Length (in)	N/A
N/A	Landing X Slope (%)	N/A	N/A	DWS Full Width?	N/A
N/A	Landing Curb? (Y/N)	N/A	N/A	DWS Offset (in)	N/A
N/A	Shared Landing?	N/A			
N/A	Gutter Ponding?	N/A	N/A	Gutter Slope (%)	N/A
N/A	Gutter Lip Ht (in)	N/A	N/A	Gutter X Slope (%)	N/A
N/A	Painted X Walk1?	No	N/A	Painted X Walk2?	No
	X Walk 1 Direction	To S		X Walk 2 Direction	To E
N/A	X Walk 1 Width (in)	N/A	N/A	X Walk 2 Width (in)	N/A
	X Walk 1 Slope (%)	1.2		X Walk 2 Slope (%)	5.6
	X Walk 1 X Slope (%)	5.1		X Walk 2 X Slope (%)	2.5

N/A	Ramp inside XWalk1?	N/A	N/A	Ramp inside XWalk2?	N/A
	Road Slope (%)	5.0	N/A	Clear Space?	N/A
	Road X Slope (%)	4.4	N/A	Clear Space to XWalk (in)	N/A
N/A	Any Obstructions?	N/A	N/A	Storm Grate/Utility Hazard?	N/A
	Obstruction Type			Storm Grate/Utility Type	
		N/A			N/A
			Yes	Surface Condition? (G/P)	Good

**Remove & Replace Curb Ramp With Two New Directional Ramps or Equivalent.**

Total Cost: \$ 3200.00
