# Access Compliance Report

## Public Rights-of-Way (Curb Ramps)

| Intersection ID: 18507 | Main Street: BROOKRIDGE_LN | Cross Street: PROVIDENCE_RD | Location: S |
| ADA ID: B74D1B337431 | Ramp Type: PerpDiag | Initial Pass/Fail: Fail | Overall Compliance: No |

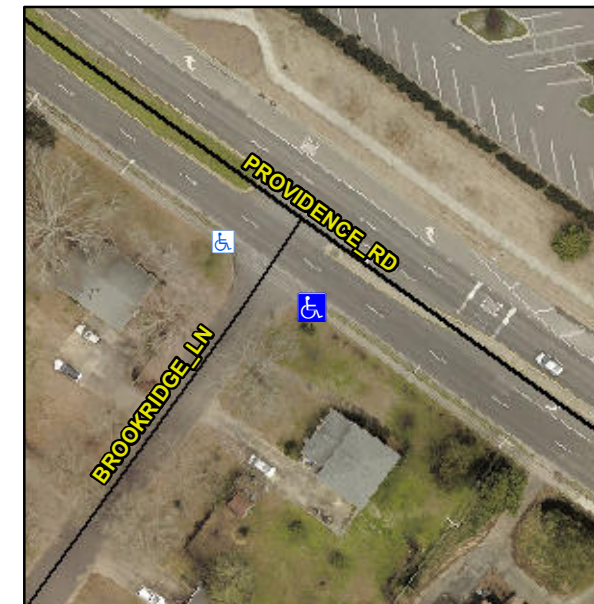
| | | Severity Score: 25 | |

**Not Found, R304.2.2**

| Compliance | Description | Data | Compliance | Description | Data |
|---|---|---|---|---|---|
| N/A | Ramp Length (in) | 37.0 | No | Ramp Slope (%) | 12.8 |
| Yes | Ramp Width (in) | 48.0 | Yes | Ramp XSlope (%) | 1.8 |

**Remove & Replace Curb Ramp With Two New Directional Ramps or Equivalent.**

Total Cost: \$ 3200.00
